ARBORIST REPORT

Tree Inventory, Tree Descriptions and Recommendations Relative to Proposed Construction

401-409 Alberto Way

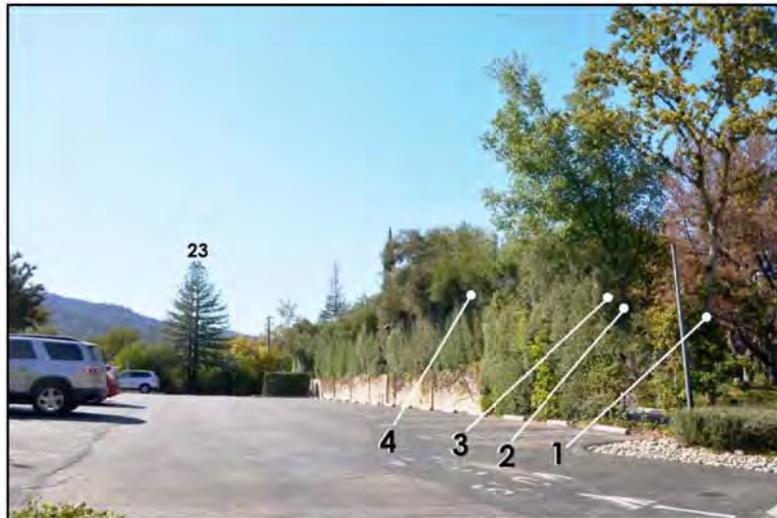
Northeast corner of the site looking east. **Coast live oaks and olives #1-4** are labeled - these are either borderline trees or are located on adjacent property to the north.

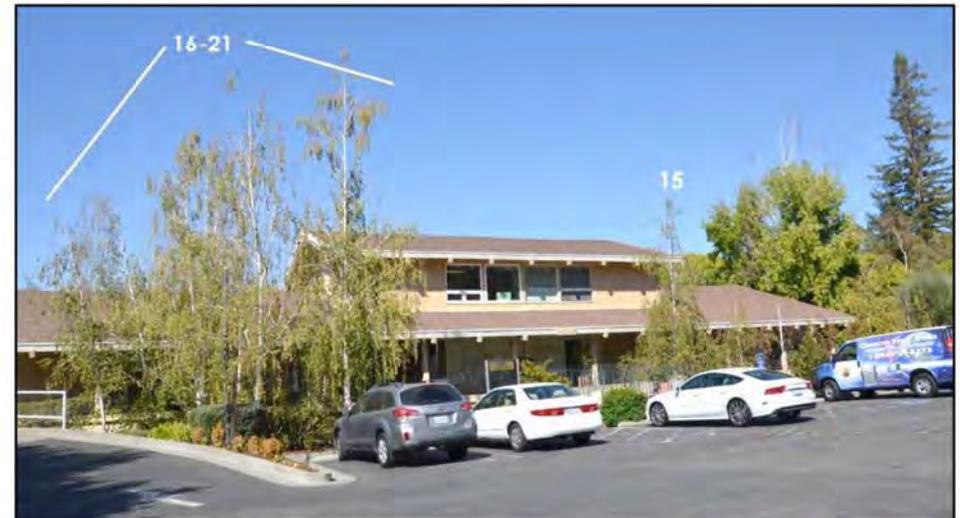
Interior of the site, 409 building with **European white birch trees #1-21**.

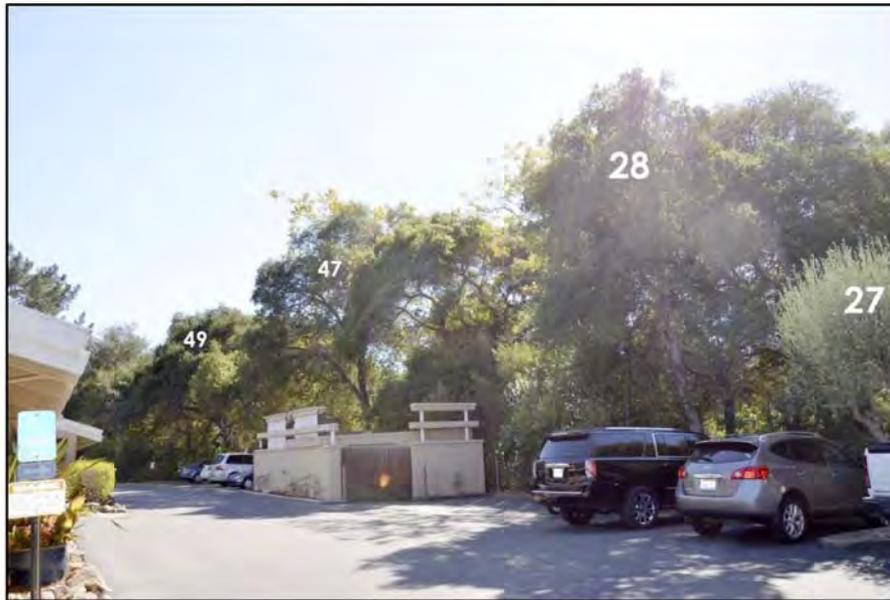
Upper photo: **olive #27** in the parking lot, and **coast live oaks #28, 47 and 49** (on adjacent property but overhanging the site. This is near the southwest corner of the property.

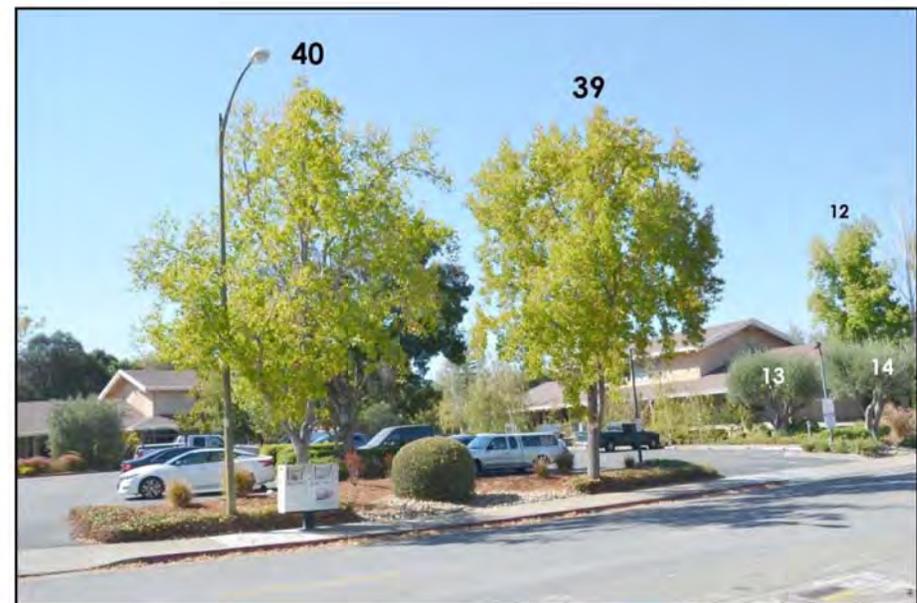
Lower photo: front (east) perimeter of the property on Alberto Way. **Sweet gums #12, 39 and 40 and olives #13 and 14** are labeled.

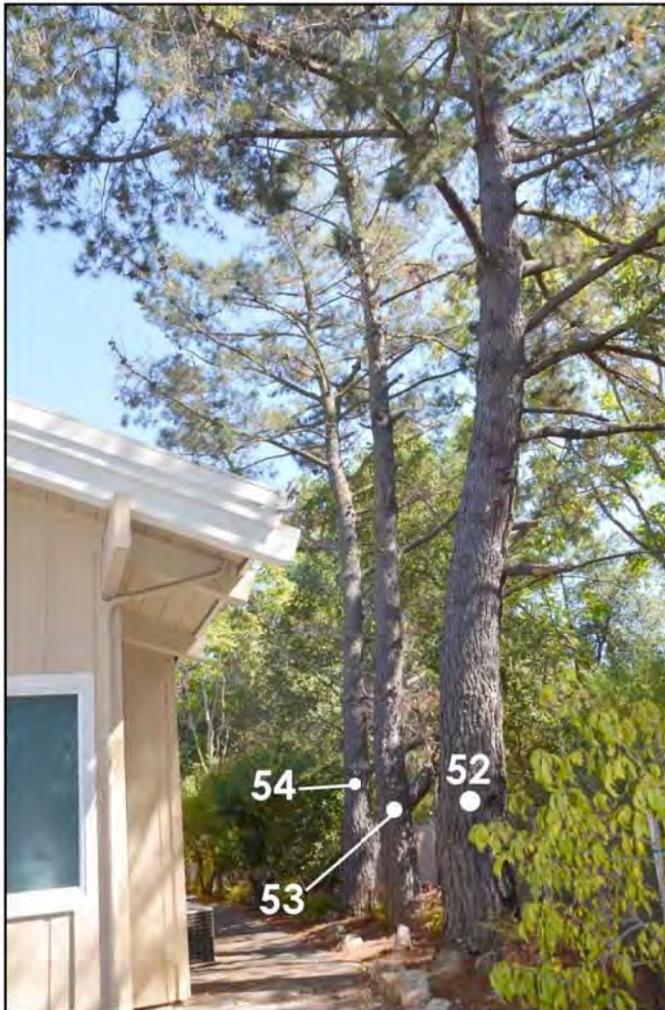
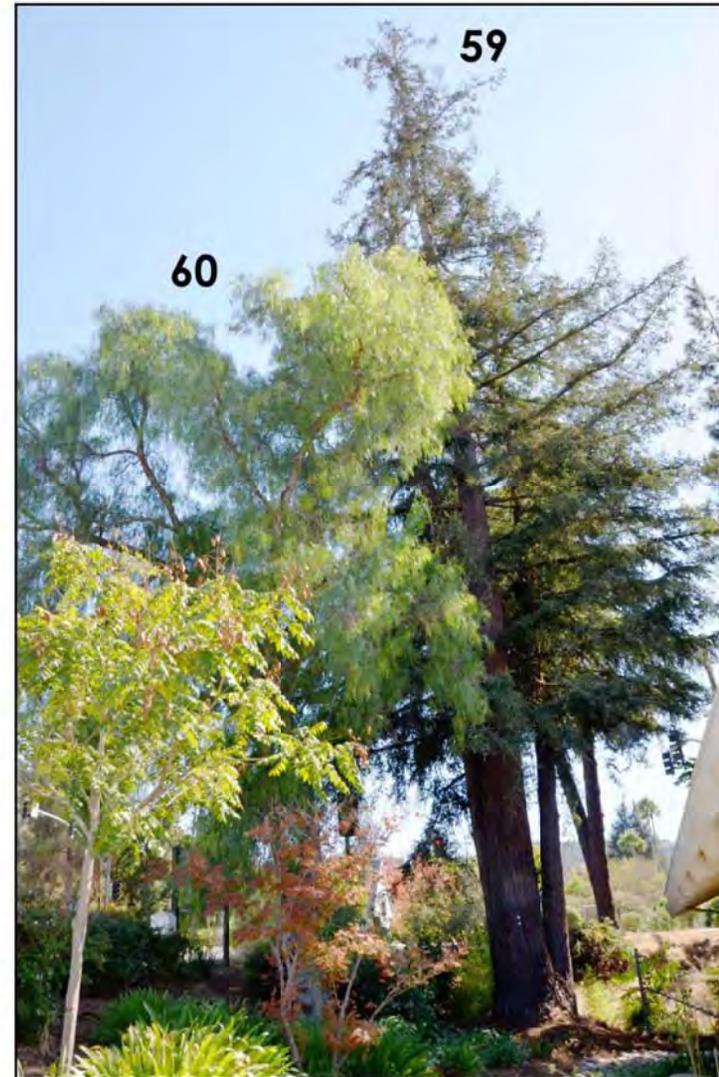
Left photo: **Monterey pines #52-54** on the south side of building 401. These pines are not in good condition and they will be removed as a part of development.
Right photo: the southeast corner of the property with Alberto Way to the left and Saratoga-Los Gatos Road in the background. Triple-trunk **redwood #59** is visible along with **California pepper #60**. It may be possible to save the redwood, but the pepper will be removed.
