APPENDIX A

**NOTICE OF PREPARATION (NOP)
AND
NOP COMMENTS RECEIVED**

Subject: Notice of Preparation of Draft Environmental Impact Report
100 Prospect Avenue, M-13-003

Project Title: Sisters of the Holy Names of Jesus and Mary, Vesting Tentative Tract Map, M-13-003

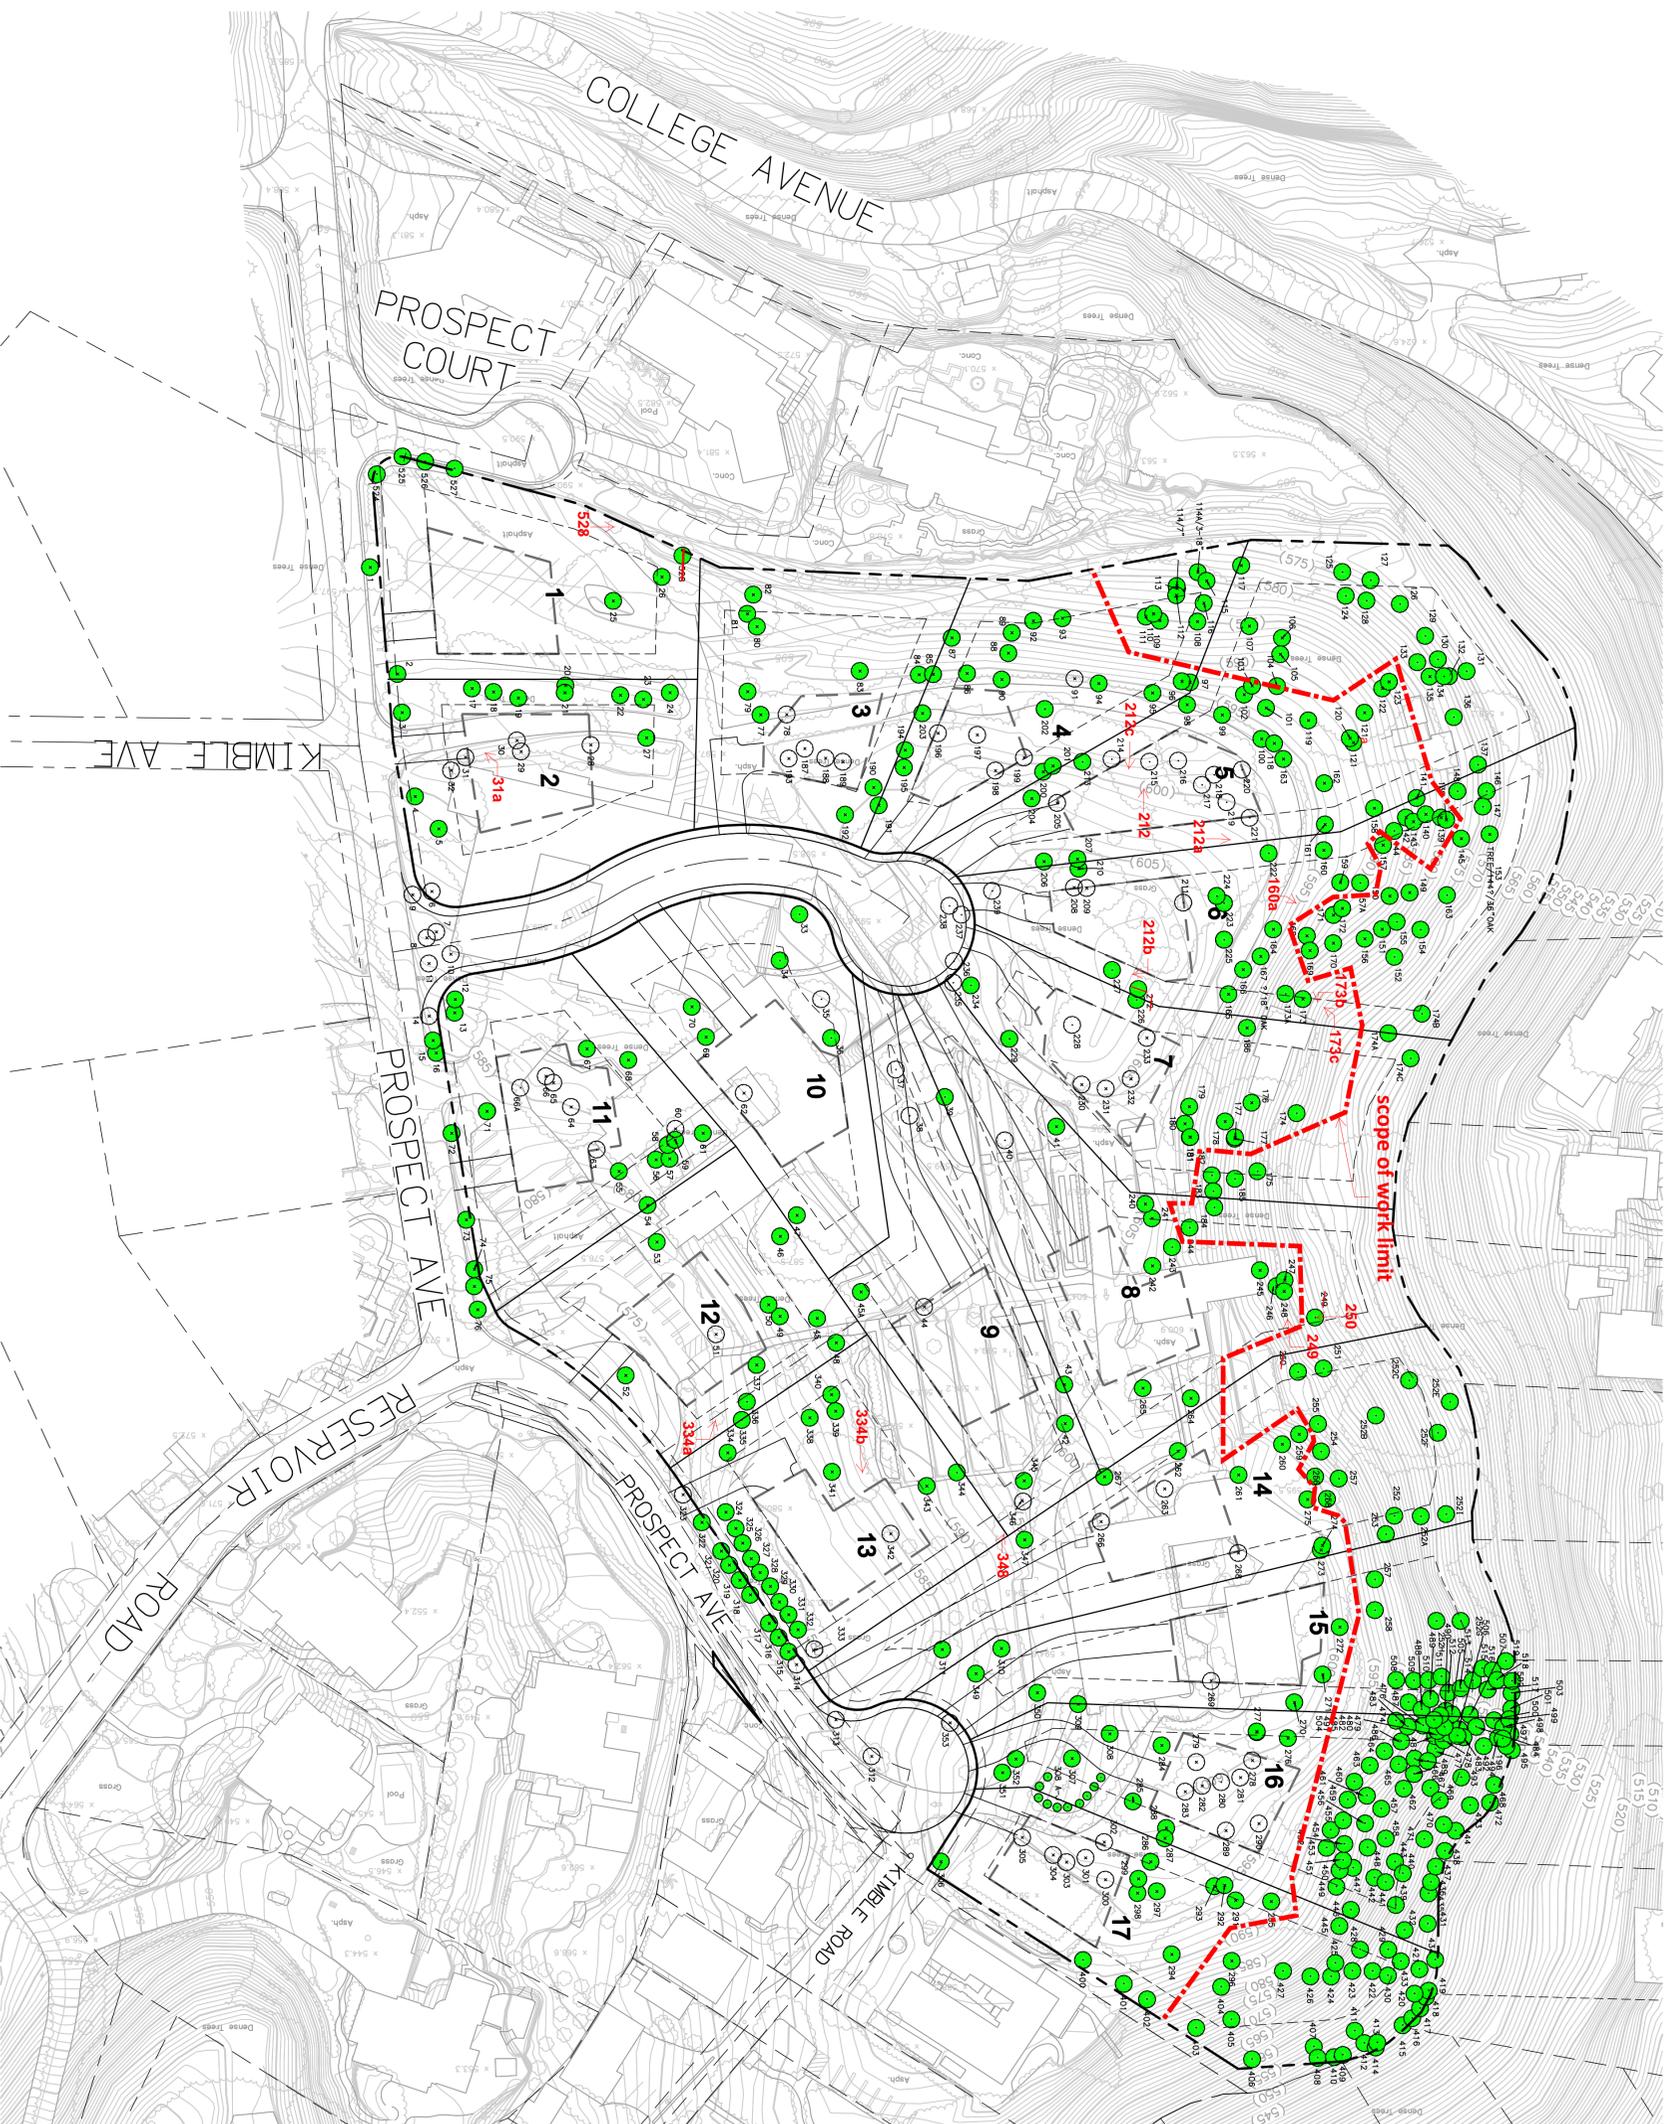
- LOT LINE
- SETBACK LINE
- CONCEPTUAL BUILDING FOOTPRINTS ONLY 2,800 - 4,800 SF SPECIFIC BUILDING LOCATIONS TO BE DETERMINED SUBJECT TO TOWN OF LOS GATOS DESIGN REGULATIONS AND FUTURE ARCHITECTURE & SITE APPLICATION, REVIEW, AND APPROVAL PROCESS
- PROPERTY LINE
- RIGHT OF WAY LINE
- EXISTING RIGHT OF WAY LINE
- STREET CENTERLINE
- # EXISTING TREE (WITH CORRESPONDING NUMBER) TO POTENTIALLY REMAIN
- # EXISTING TREE (WITH CORRESPONDING NUMBER) TO POTENTIALLY BE REMOVED

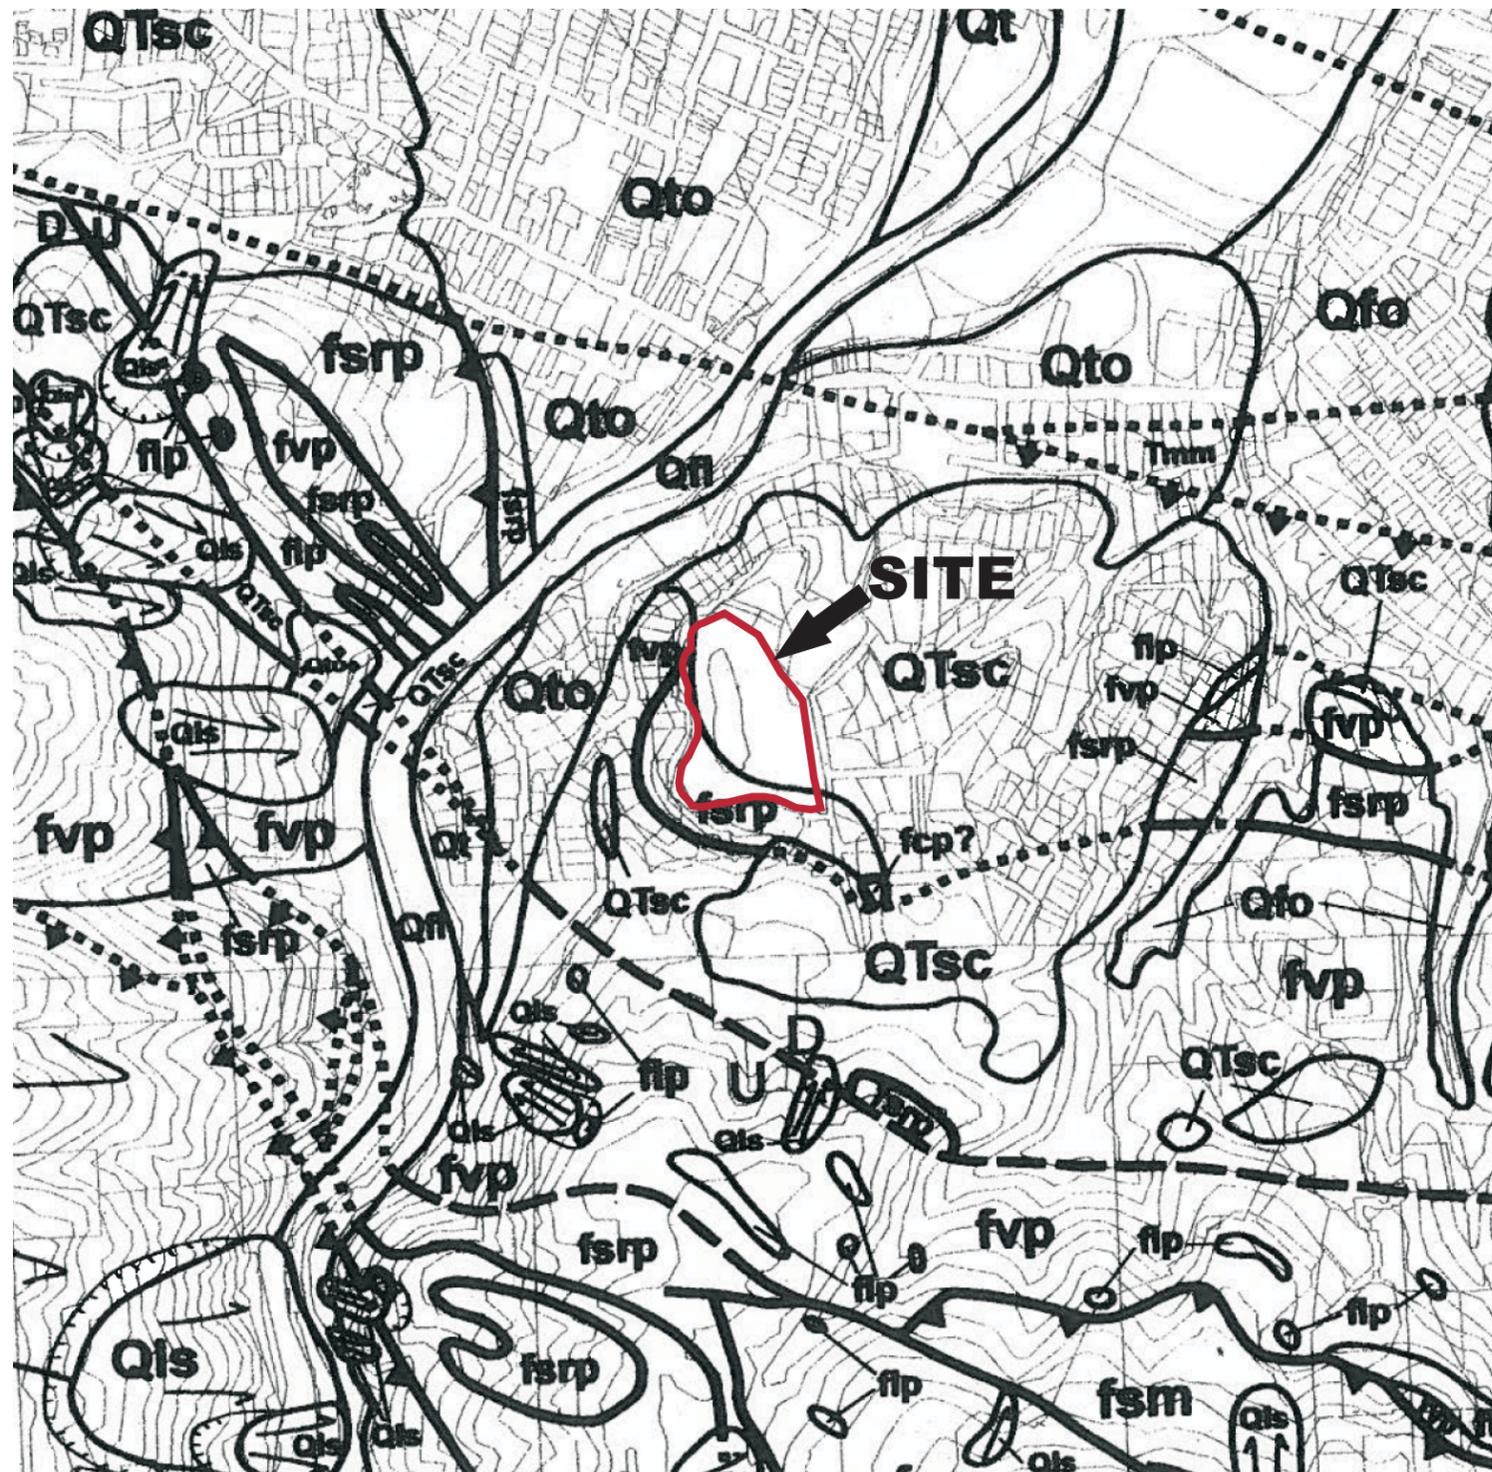
| Vicinity Geologic Map Sisters of the Holy Names of Jesus and Mary 100 and 200 Prospect Avenue Los Gatos, CA | Project Number 440-1-4 | Figure Number Figure 4 | Date March 2013 | Drawn By MGV, RRN |

| Qfi | MODERN FLUVIAL DEPOSITS (HOLOCENE) - Poorly to well-sorted sandy silt, silty sand, and sandy gravel with minor cobbles. | Tmm | MONTEREY SHALE (MIDDLE MIOCENE) - Mudstone, porcellanite, and cherty porcellanite. |

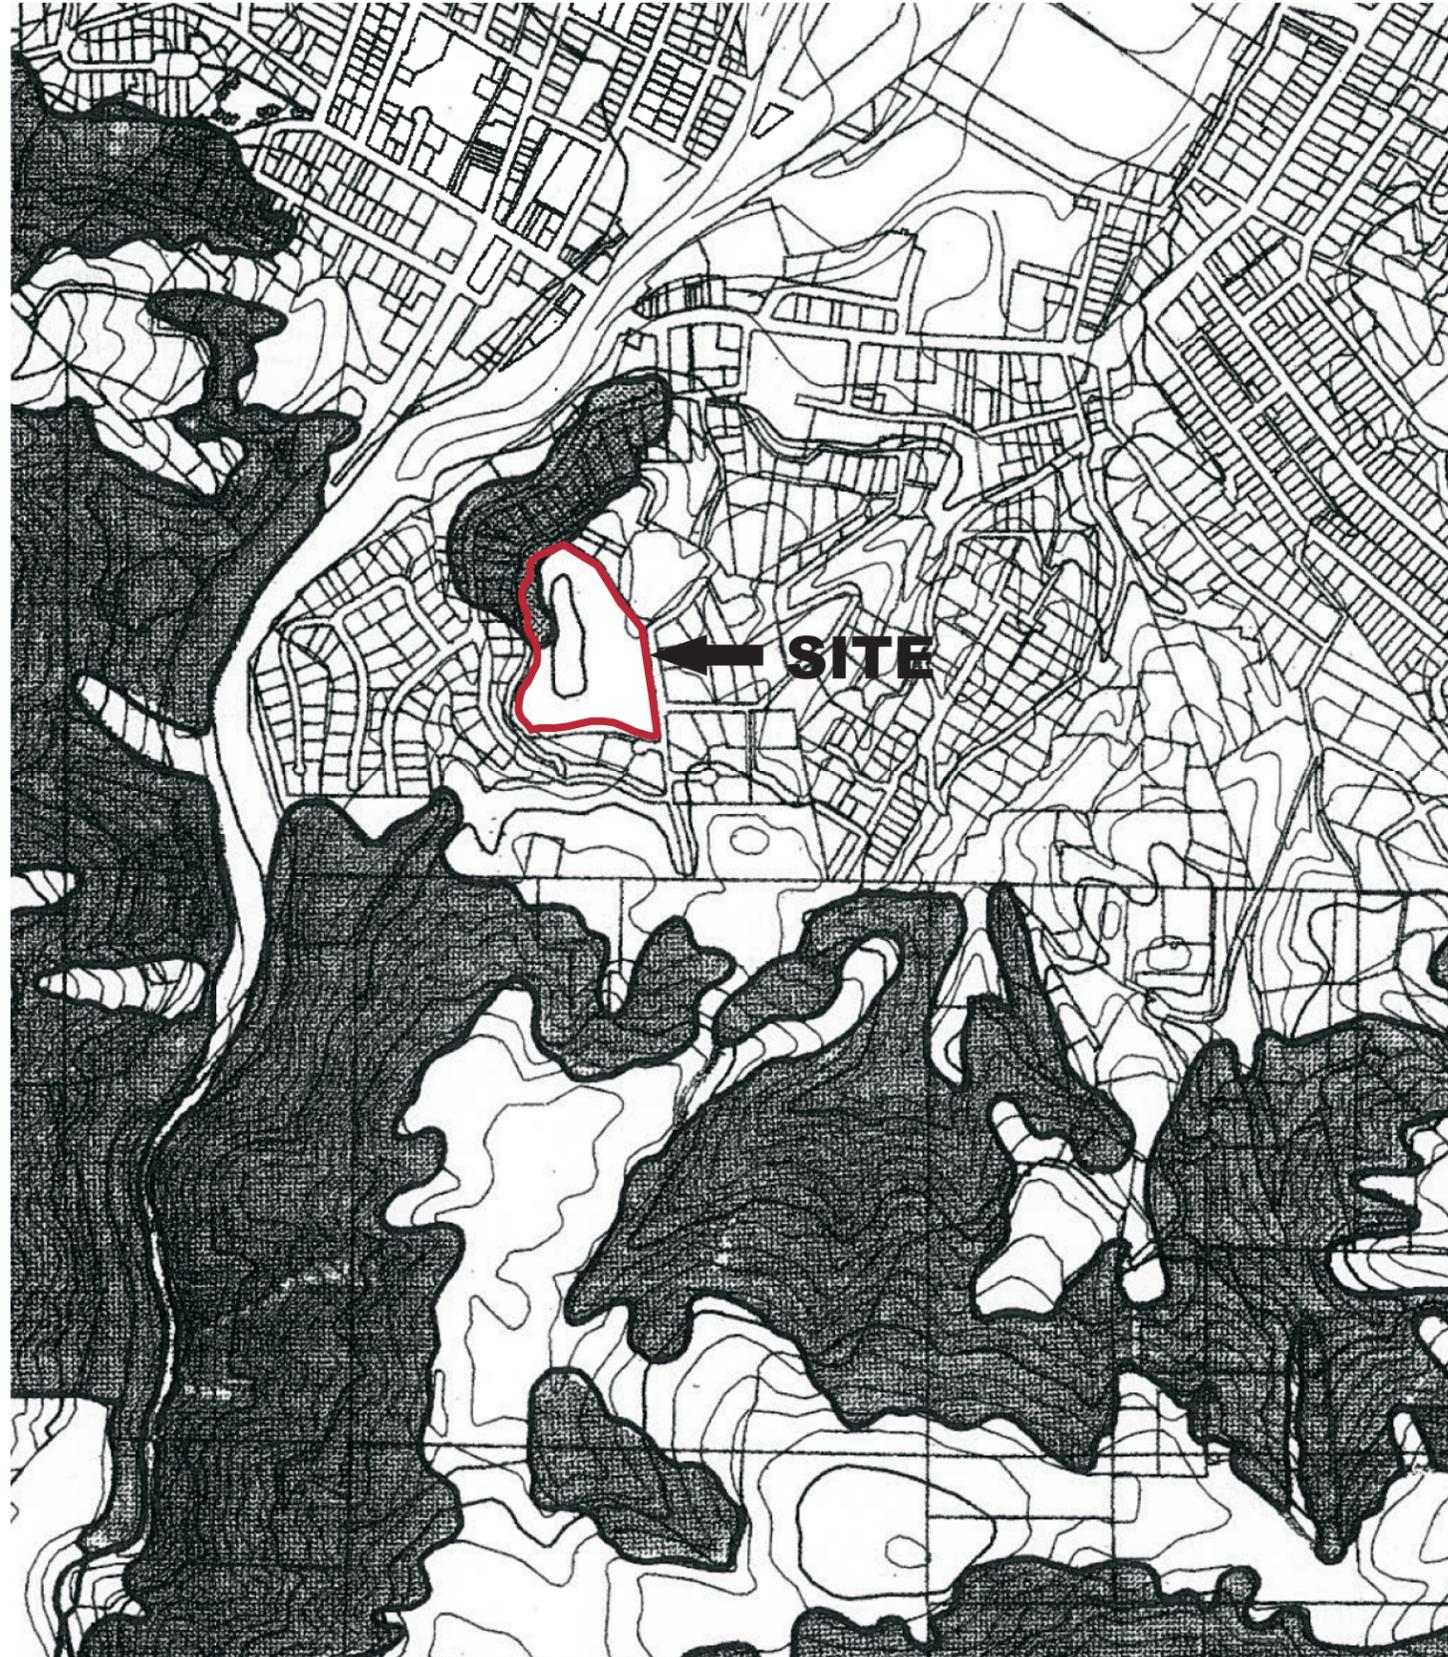
Figure Number
Figure 8

Areas of potential debris flow hazard

Debris Flow Hazard Map
 Sisters of the Holy Names
 of Jesus and Mary
 100 and 200 Prospect Avenue
 Los Gatos, CA

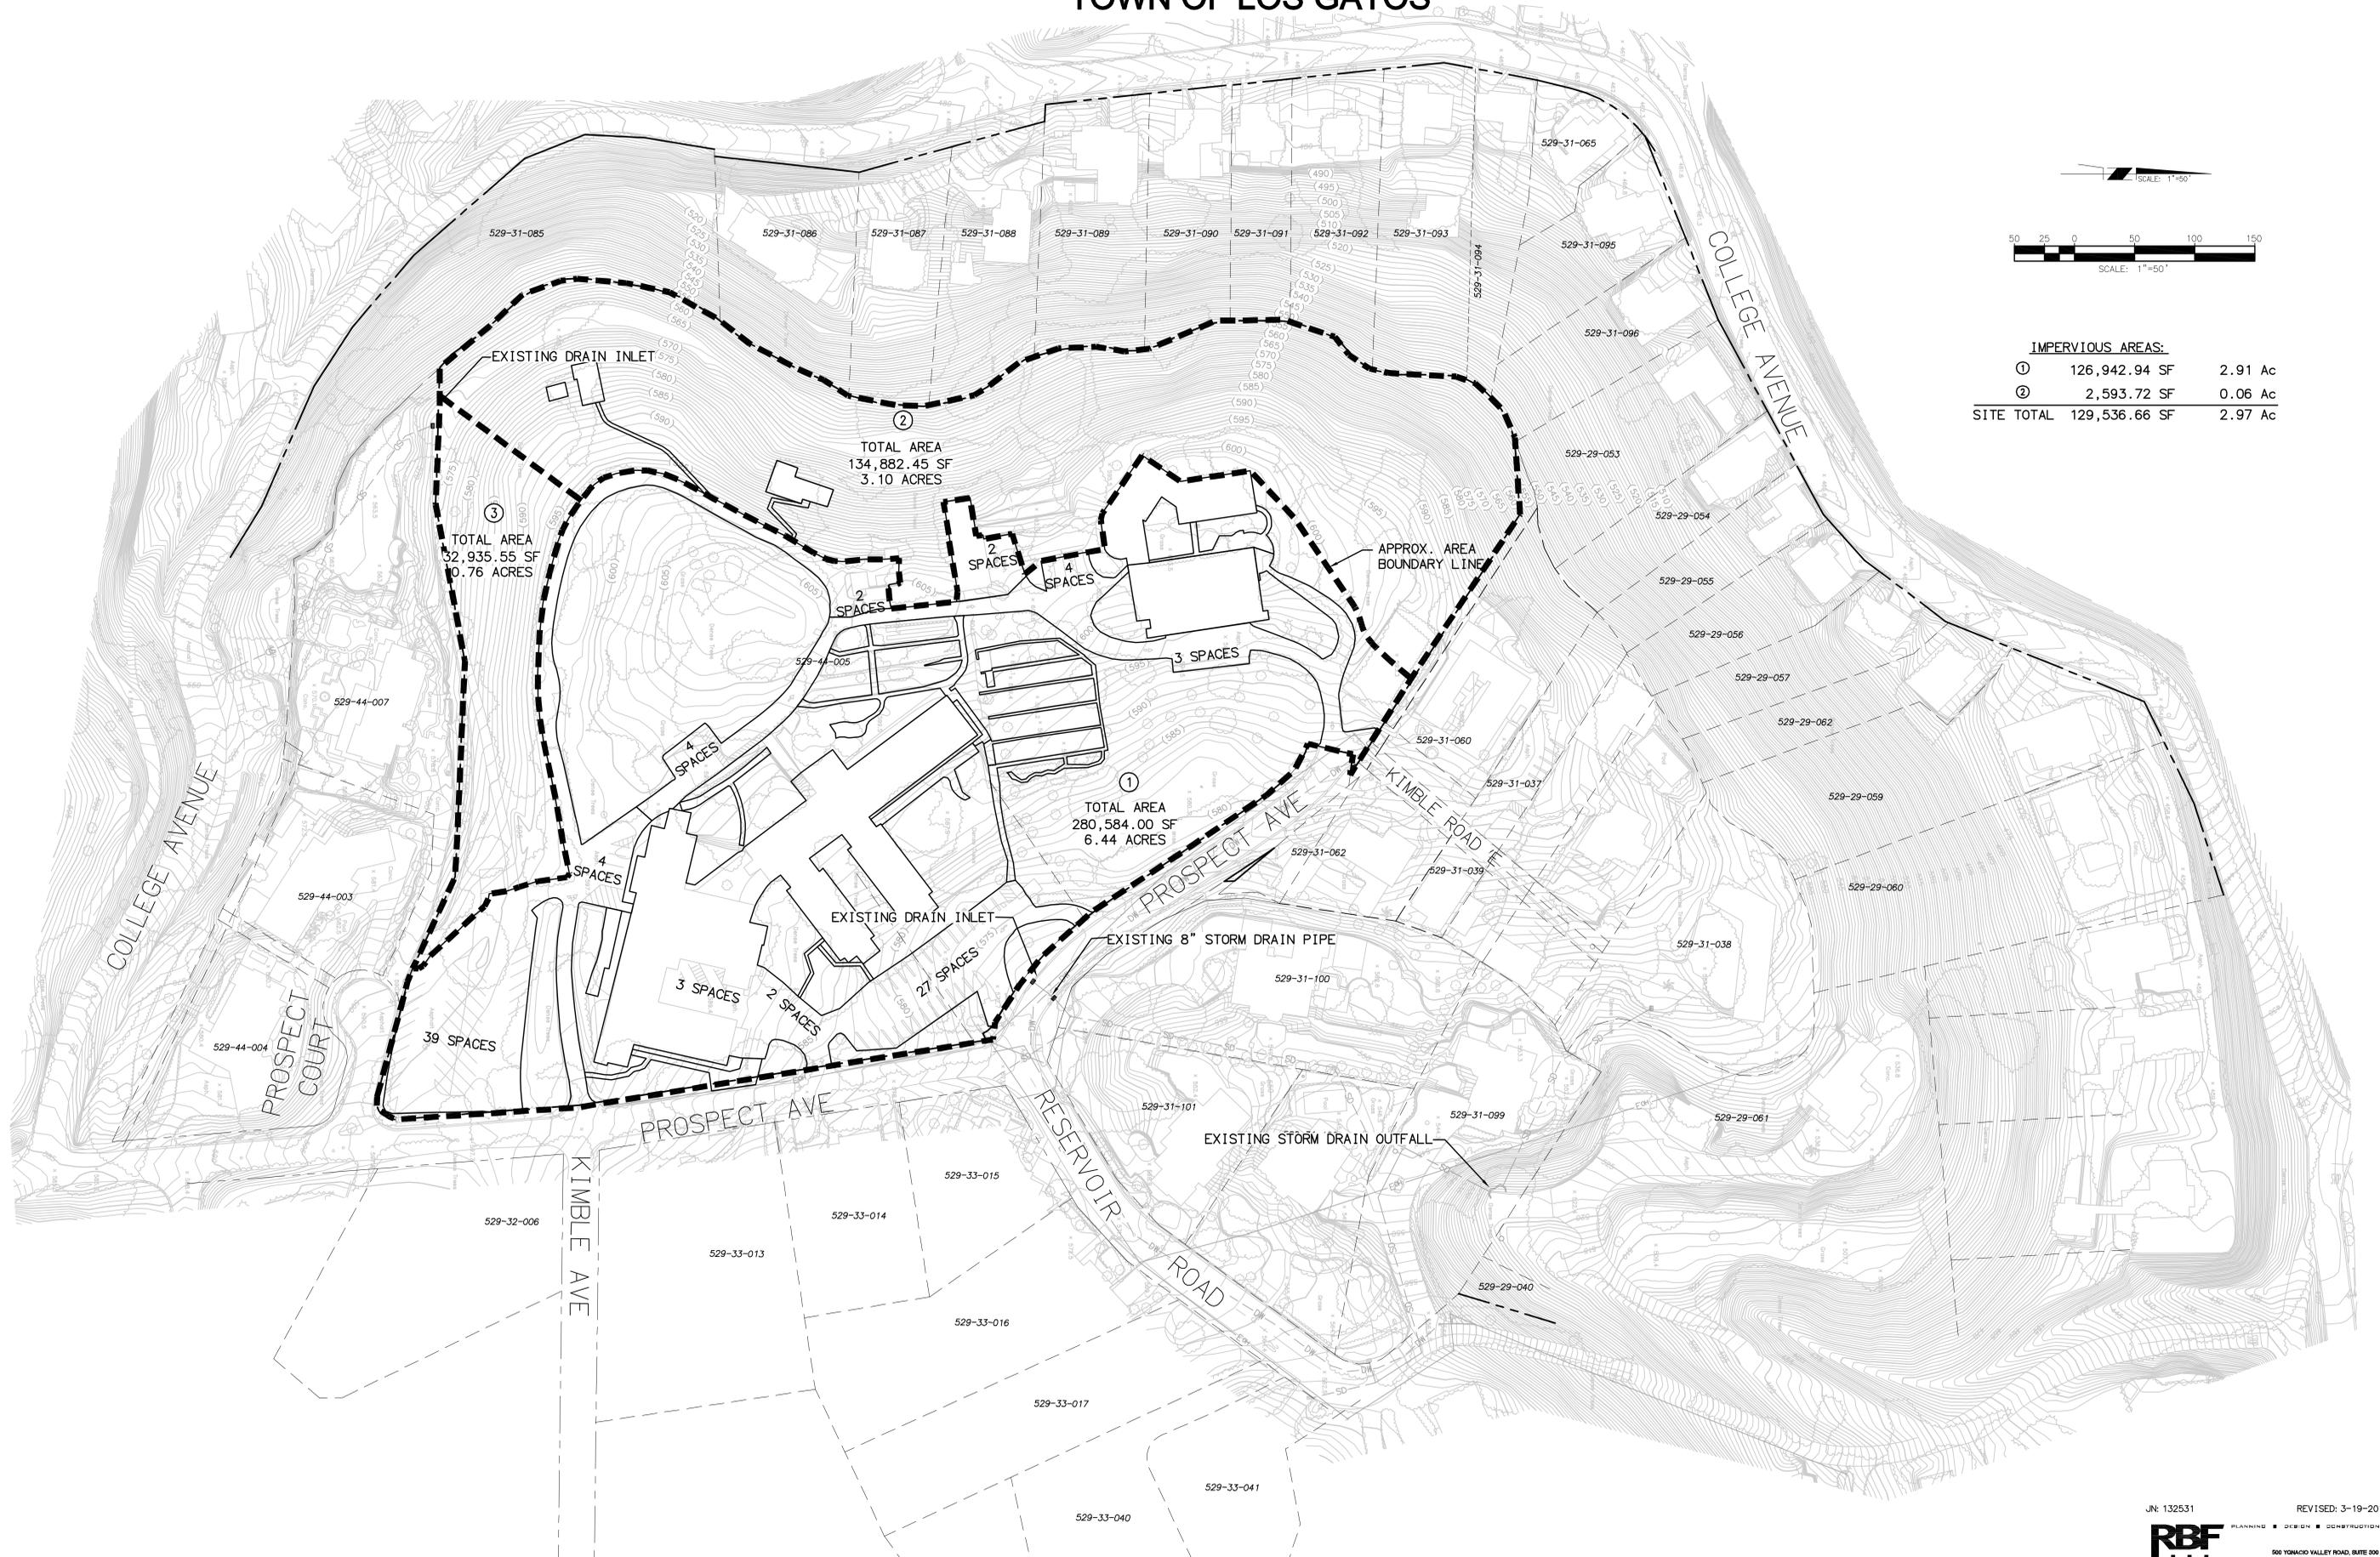
EXHIBIT 1 -- EXISTING CONDITIONS DRAINAGE AREAS SISTERS OF THE HOLY NAMES TOWN OF LOS GATOS

IMPERVIOUS AREAS:

| ① | 126,942.94 SF | 2.91 Ac |

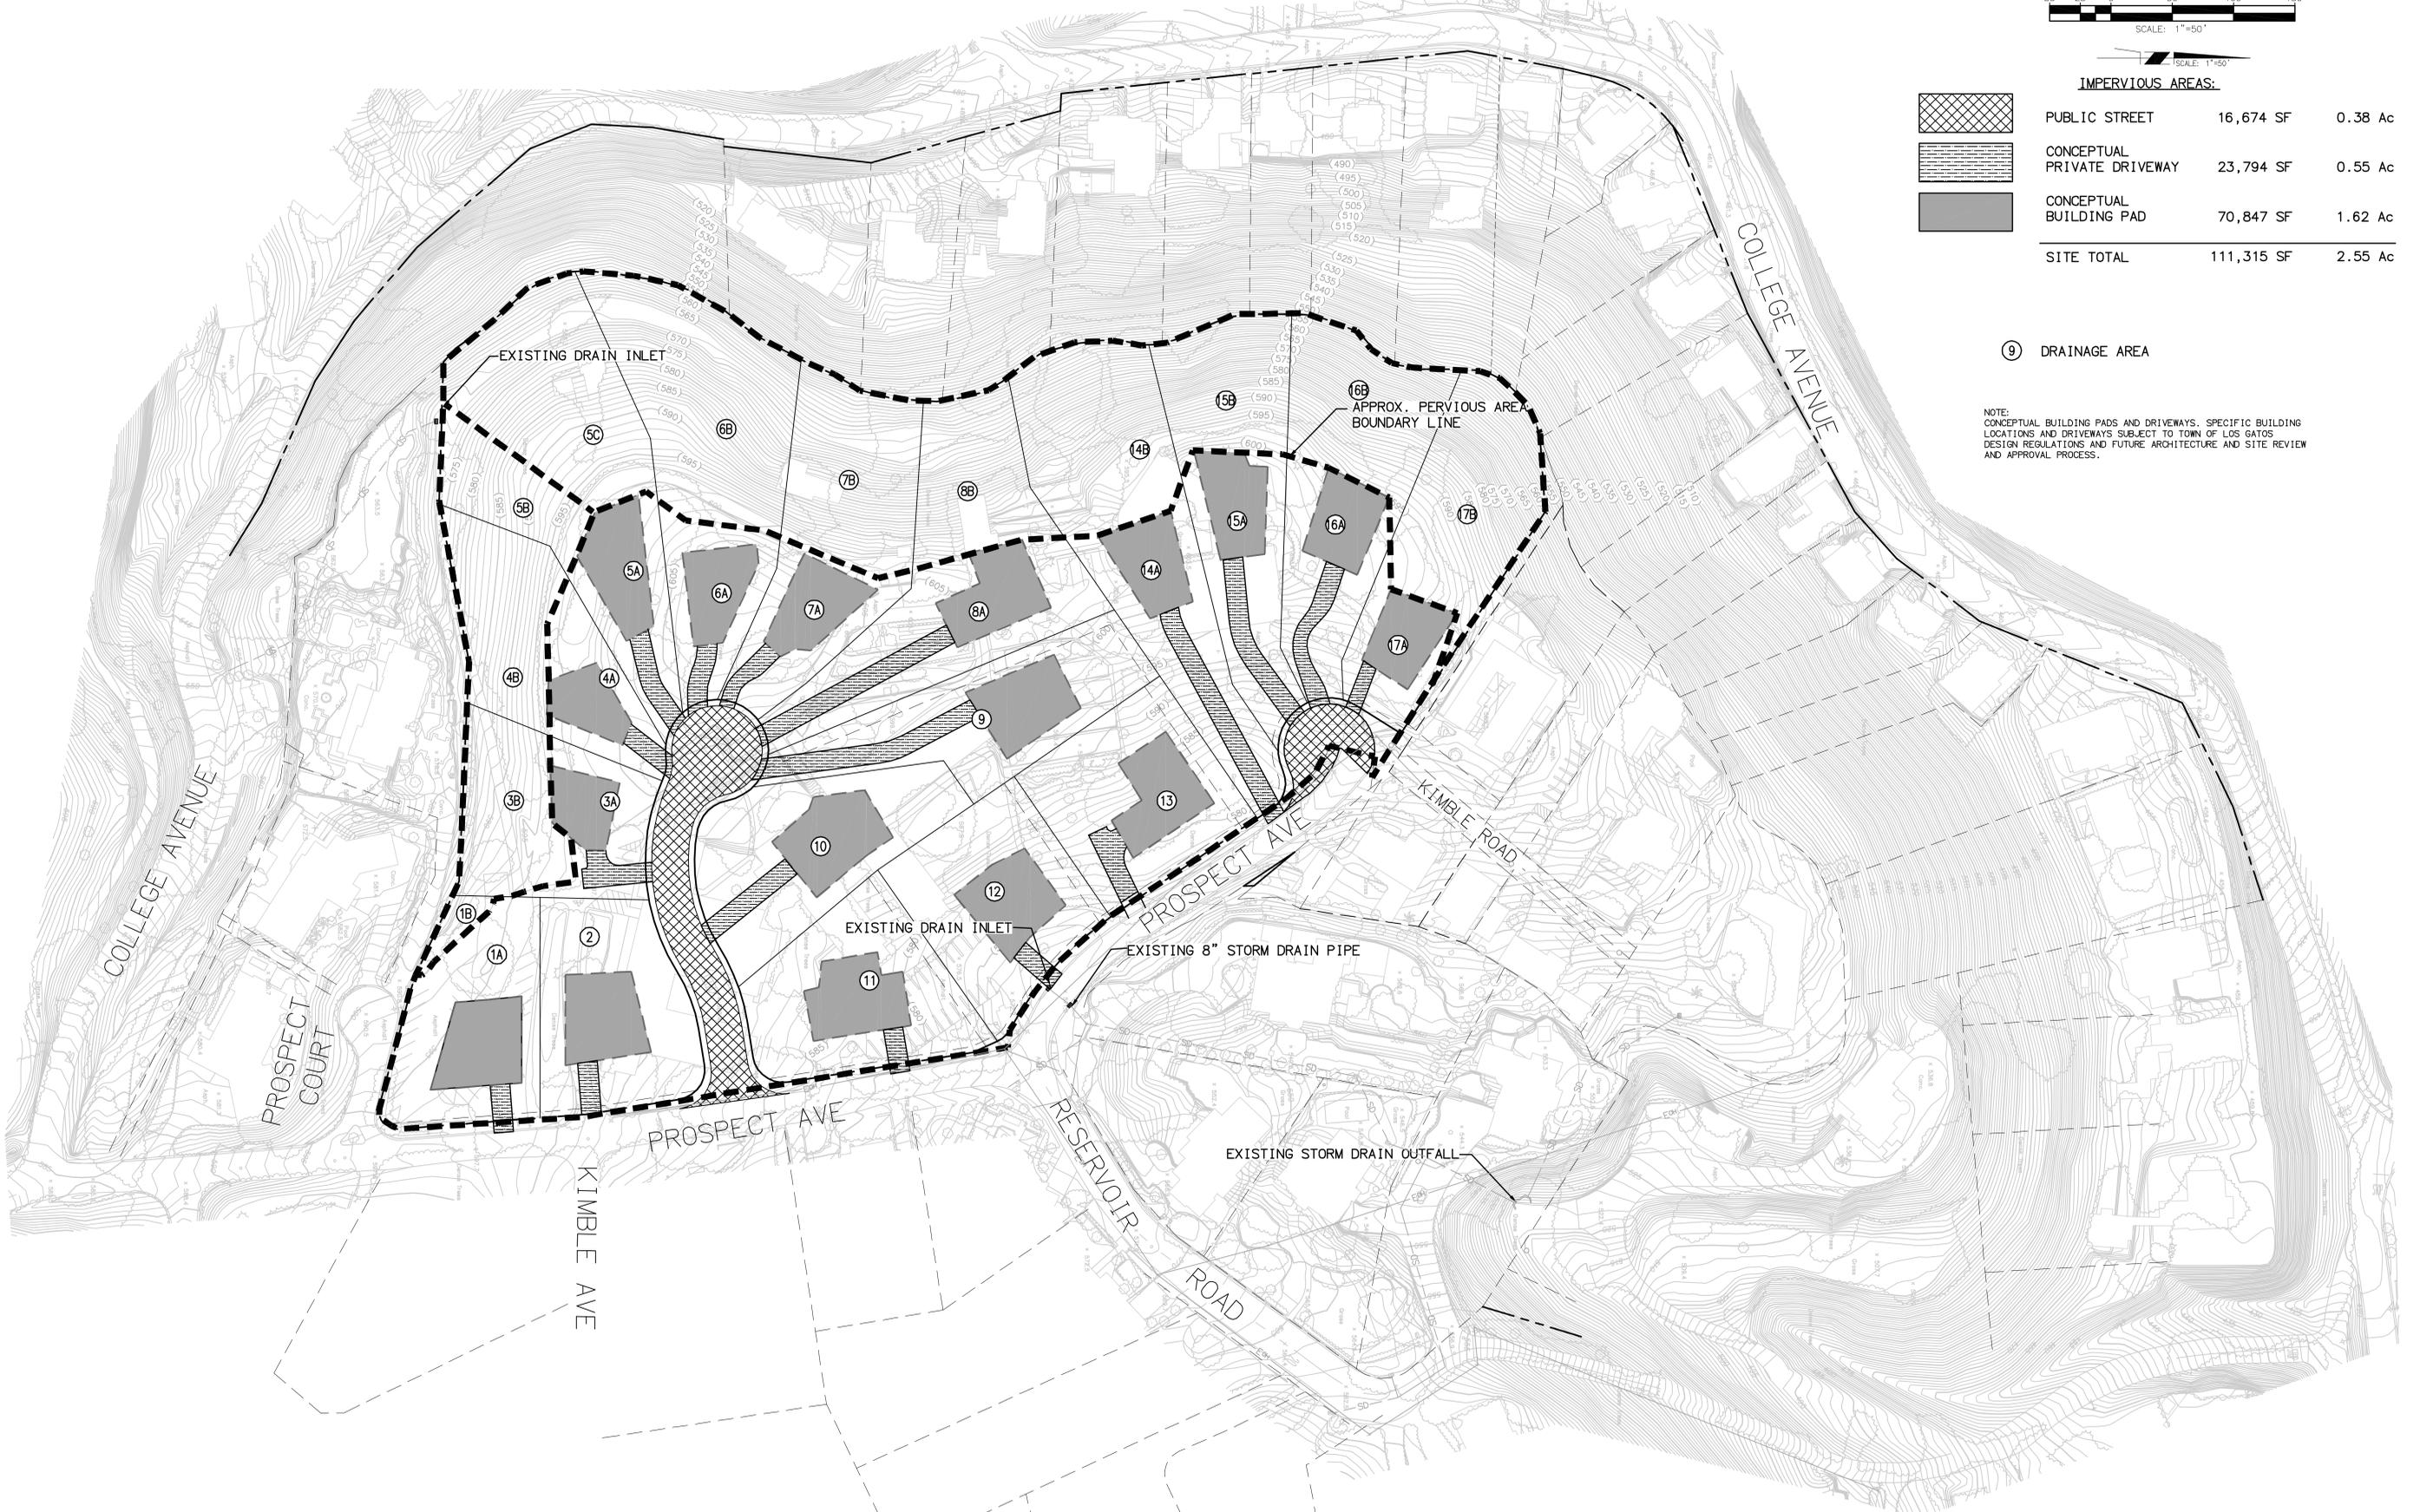
EXHIBIT 3 STORMWATER CONCEPTUAL POTENTIAL TREATMENT AREAS EXHIBIT (FOR CEQA PURPOSES ONLY)

NOTE:
CONCEPTUAL BUILDING PADS AND DRIVEWAYS, SPECIFIC BUILDING LOCATIONS AND DRIVEWAYS SUBJECT TO TOWN OF LOS GATOS DESIGN REGULATIONS AND FUTURE ARCHITECTURE AND SITE REVIEW AND APPROVAL PROCESS.

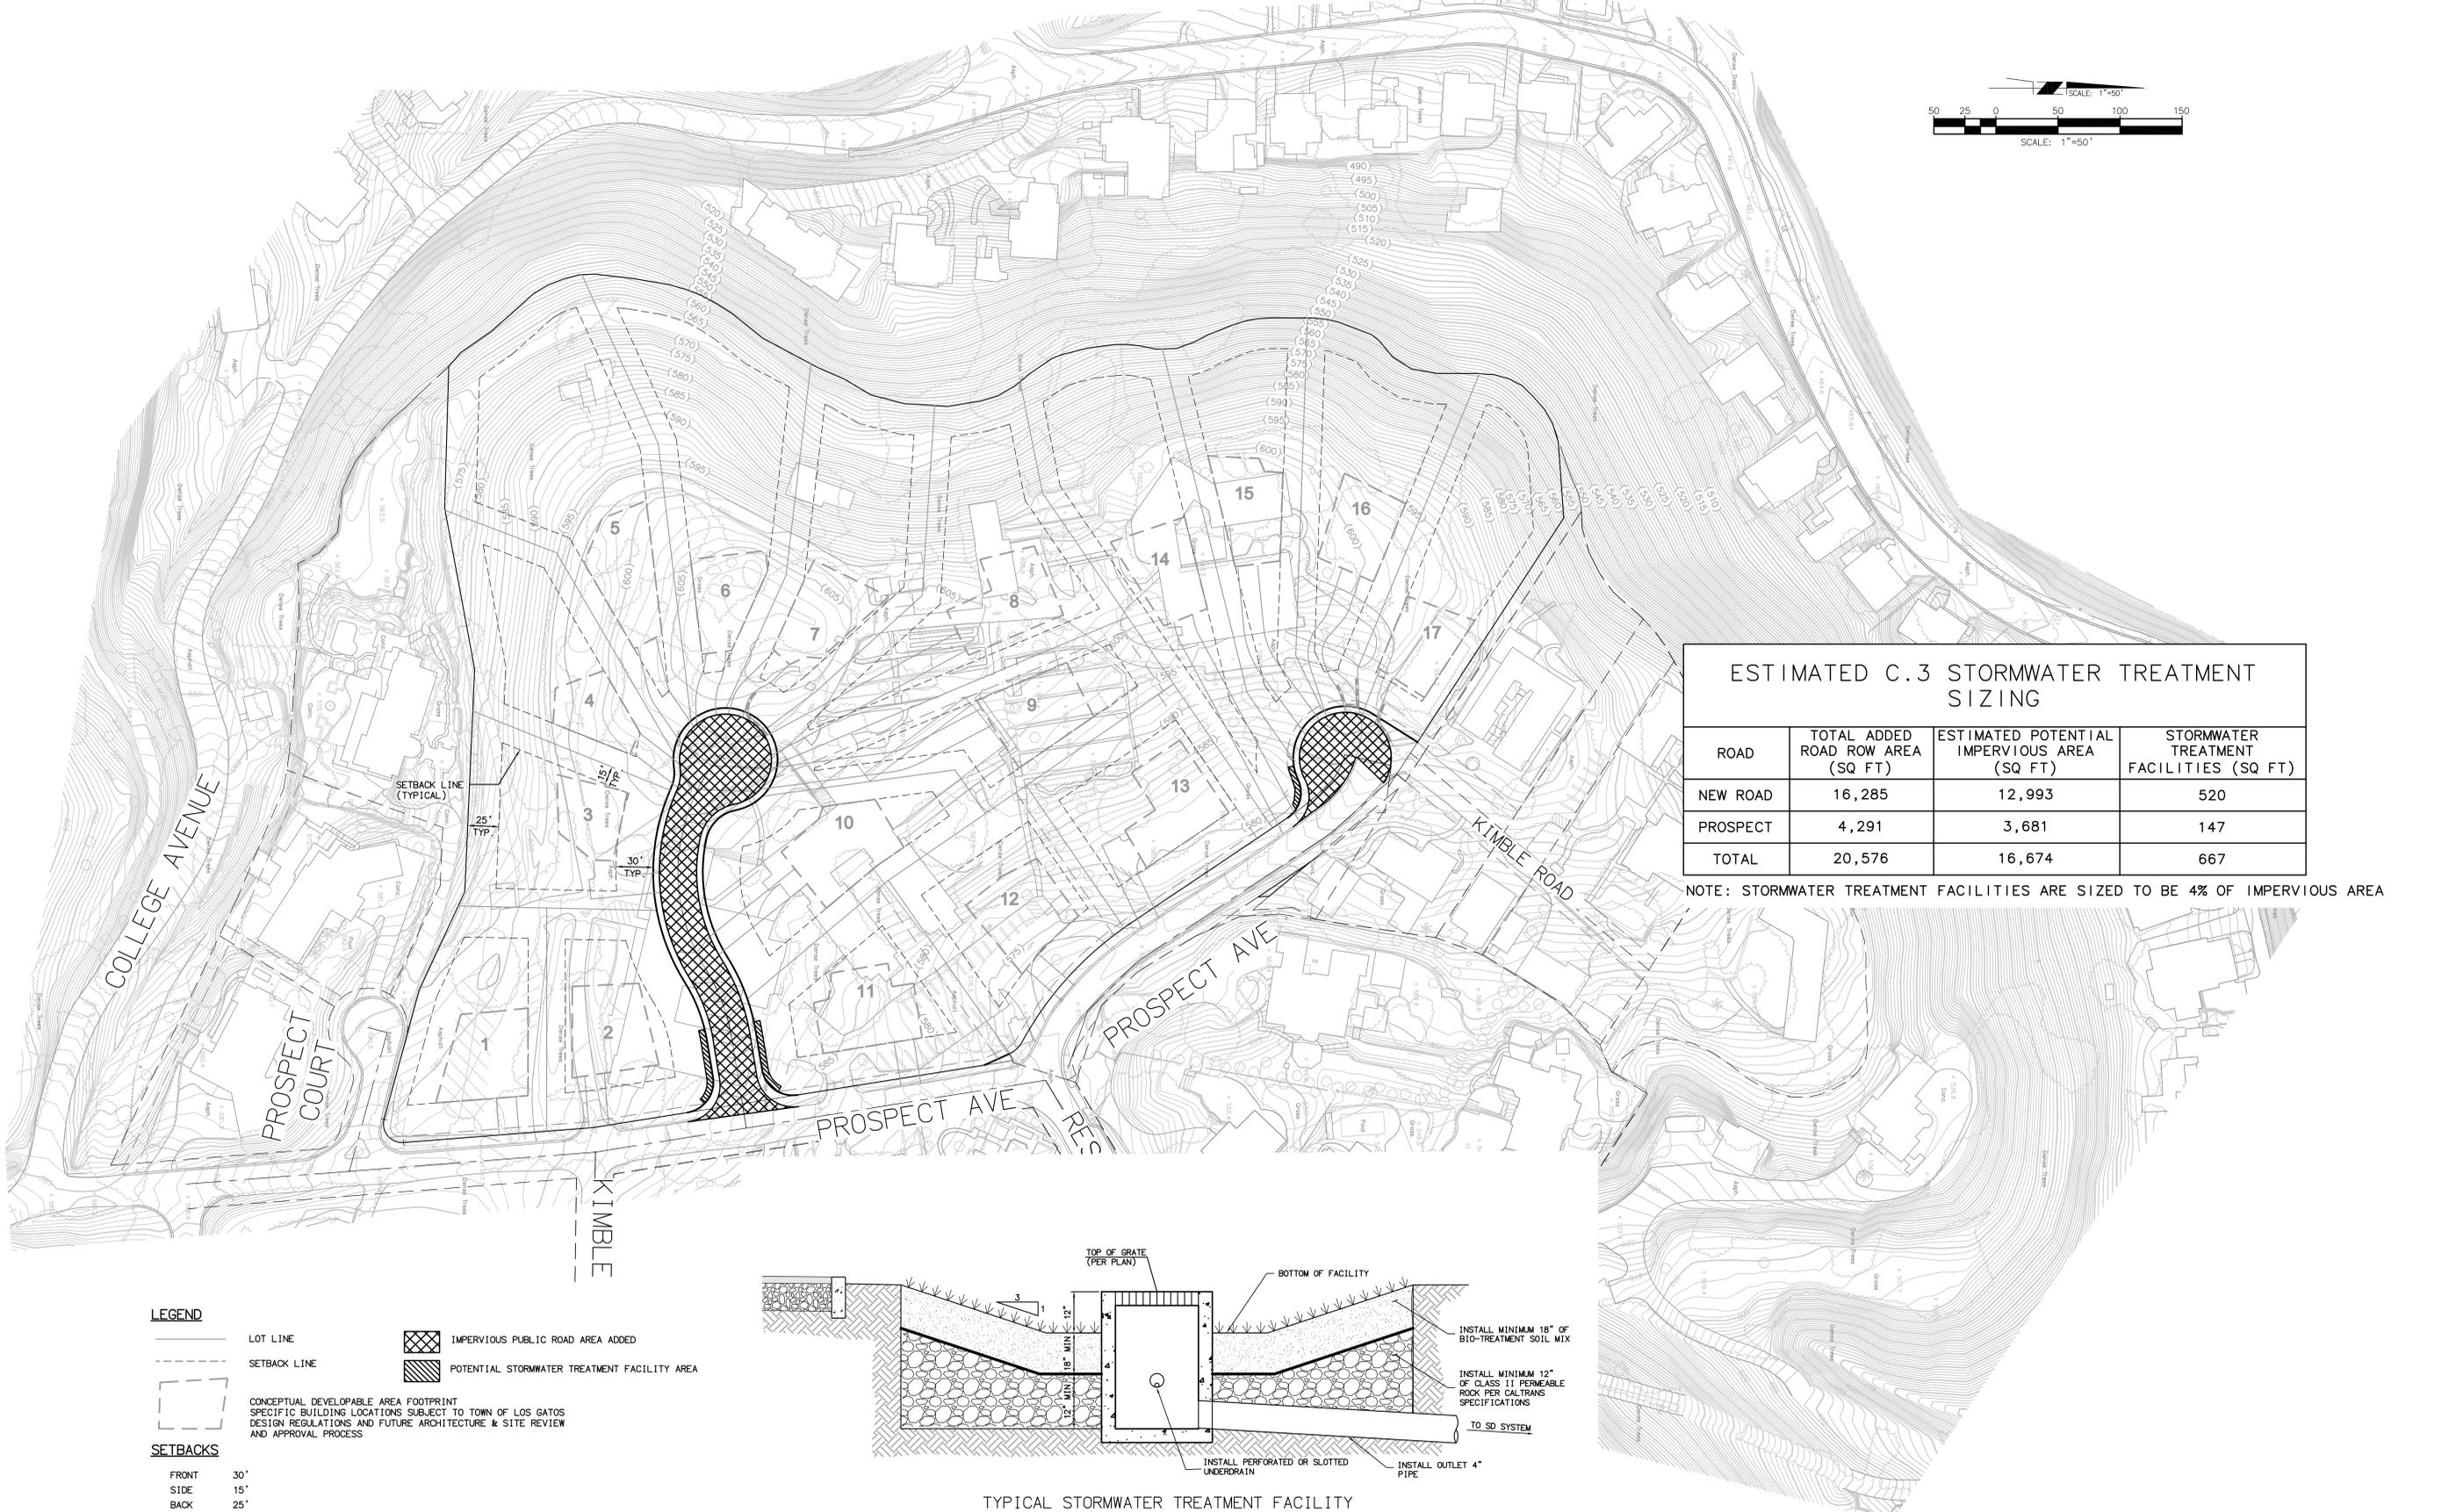
| ESTIMATED C.3 STORMWATER TREATMENT SIZING | | | |
| ROAD | TOTAL ADDED ROAD ROW AREA (SQ FT) | ESTIMATED POTENTIAL IMPERVIOUS AREA (SQ FT) | STORMWATER TREATMENT FACILITIES (SQ FT) |

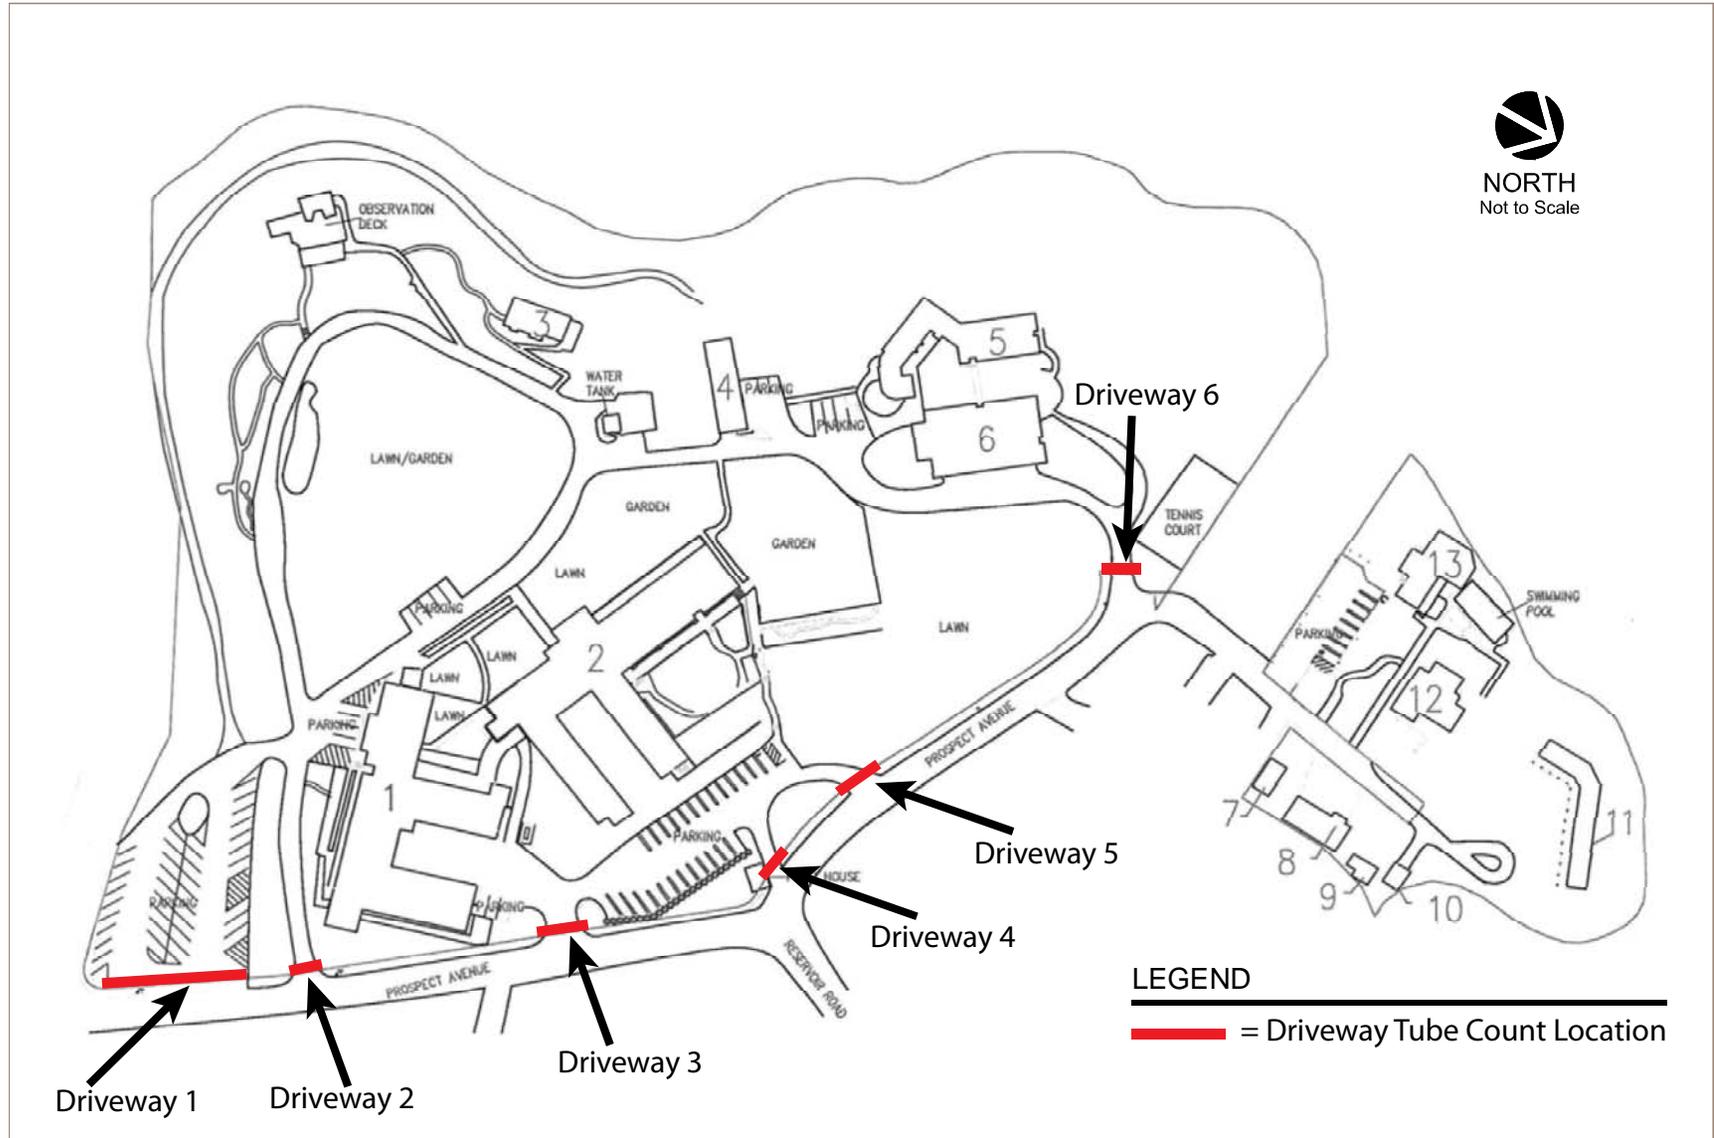
Figure 1
Driveway Count Locations

| Total Traffic Generated at the Project Site (Driveway 1-6 as shown in Figure 1) | Standard Peak Commute Hours | | | | | | Peak HS Arrival & Departure Periods | | | | | | Daily | | |
