APPENDIX A

**NOTICE OF PREPARATION (NOP)
AND
NOP COMMENTS RECEIVED**

Subject: Notice of Preparation of Draft Environmental Impact Report
100 Prospect Avenue, M-13-003

Project Title: Sisters of the Holy Names of Jesus and Mary, Vesting Tentative Tract Map, M-13-003

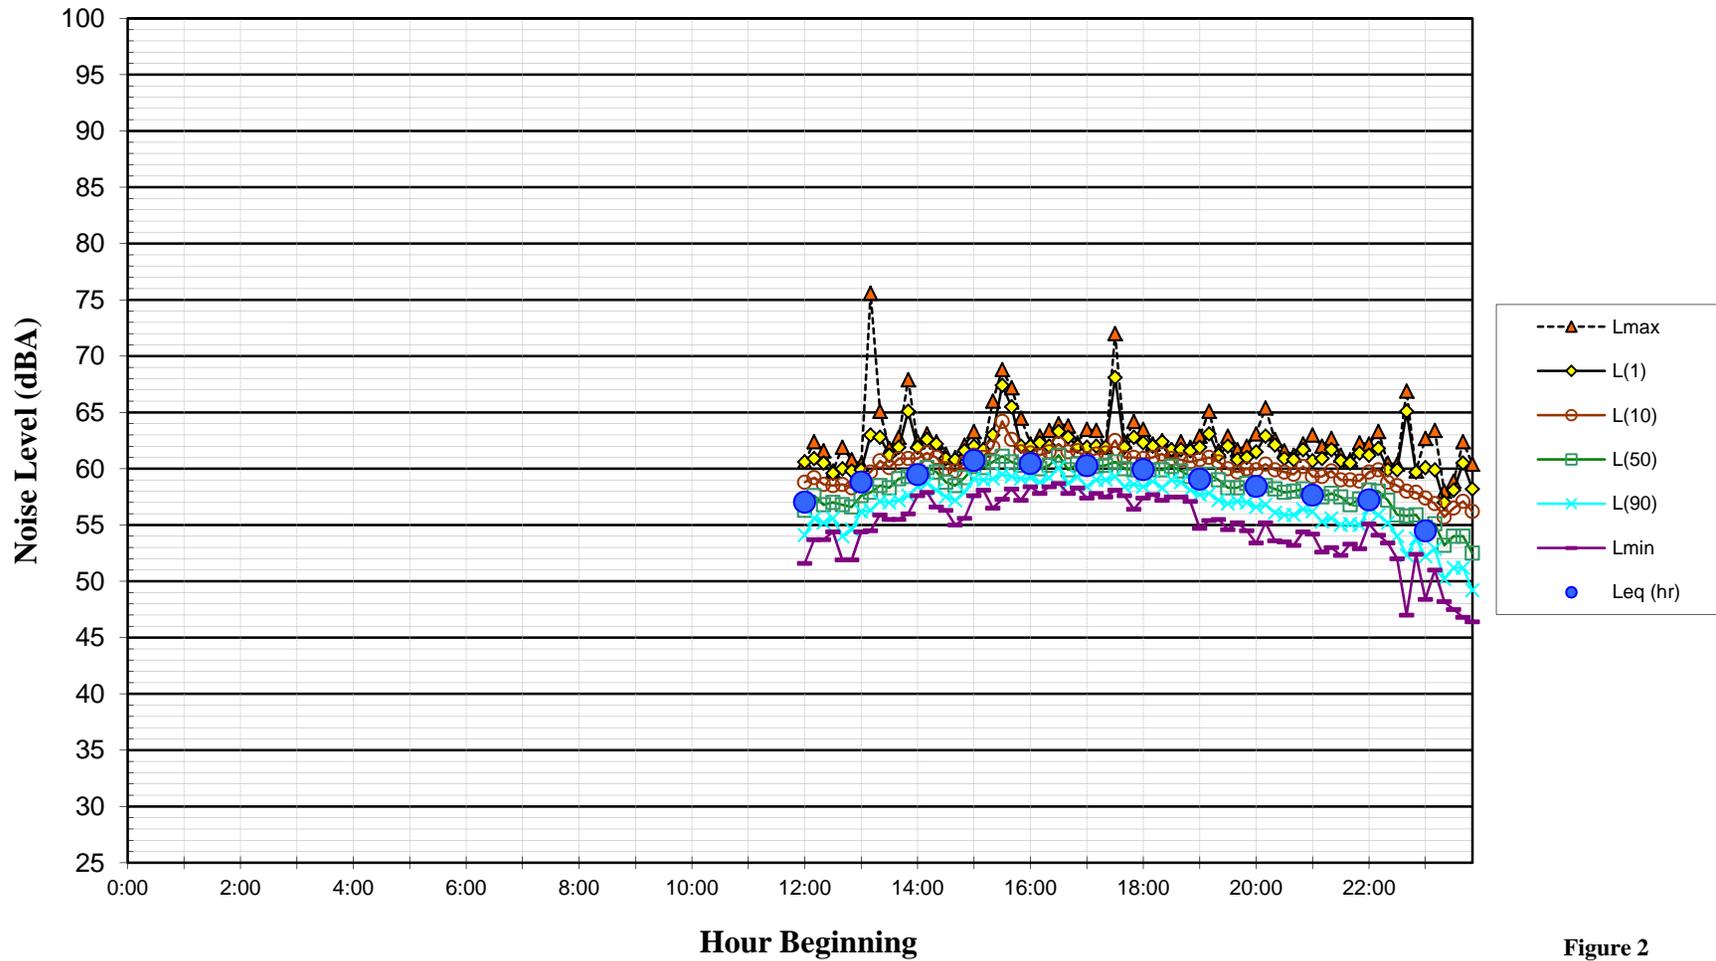
**Noise Levels at Noise Measurement Site LT-1
Northwest Portion of Site, ~800 feet from the Center of SR-17
Thursday, December 6, 2012**

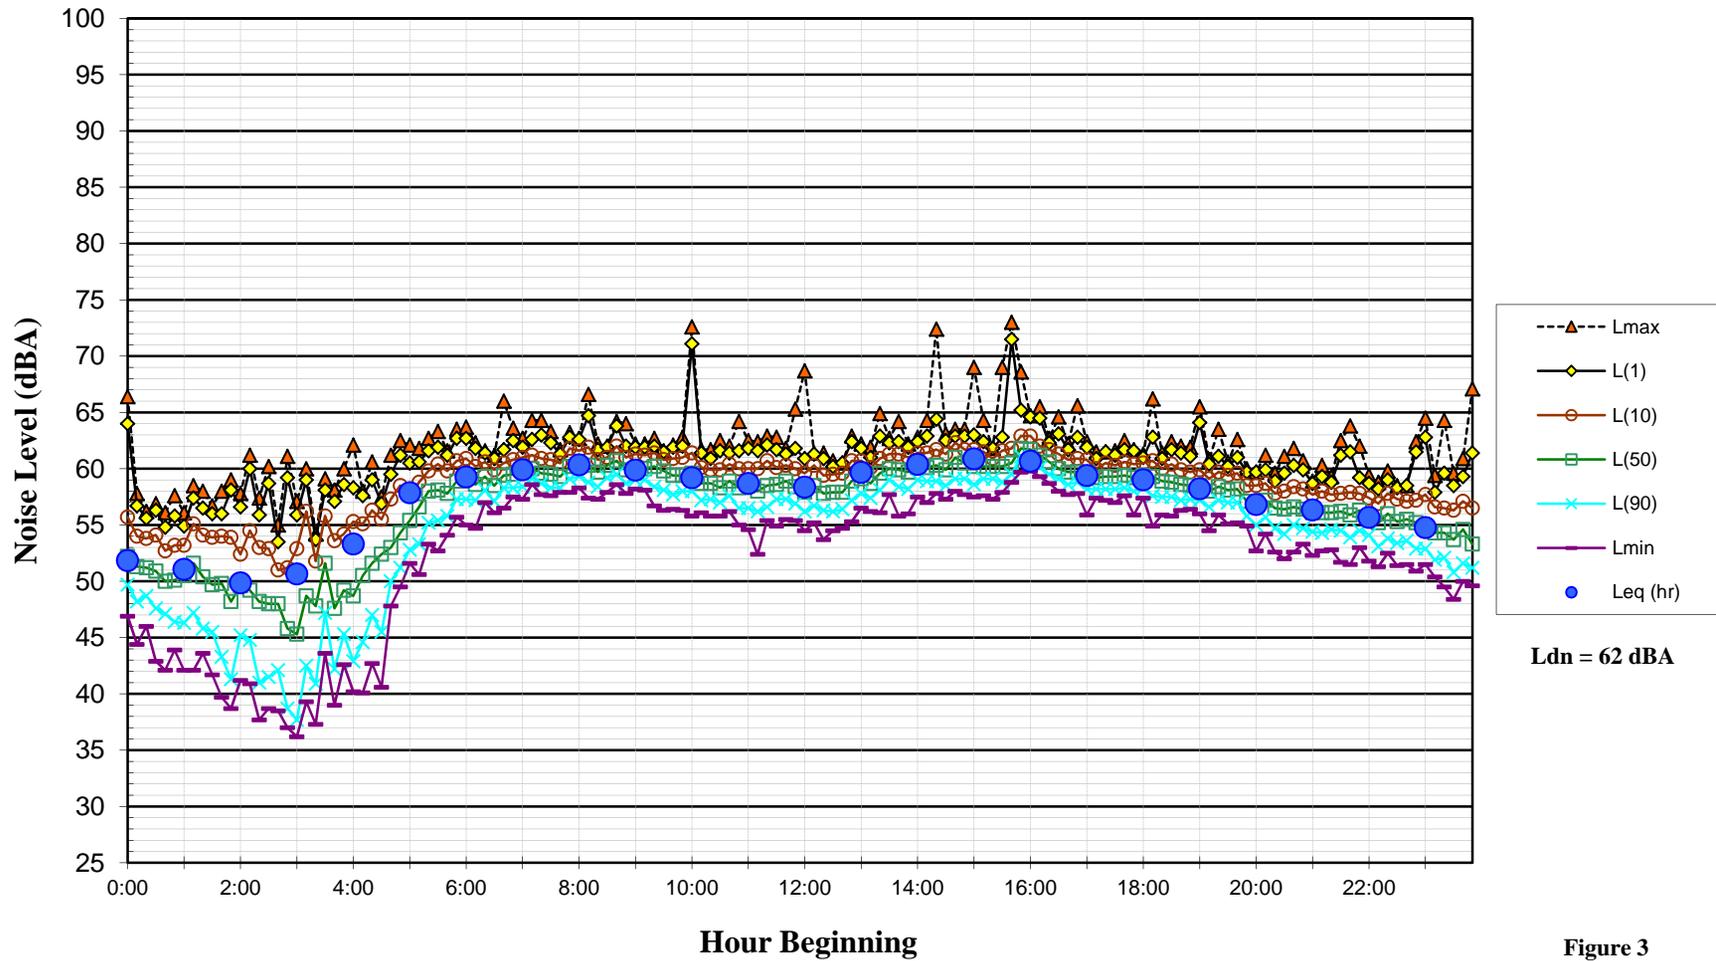
Figure 2

**Noise Levels at Noise Measurement Site LT-1
Northwest Portion of Site, ~800 feet from the Center of SR-17
Friday, December 7, 2012**

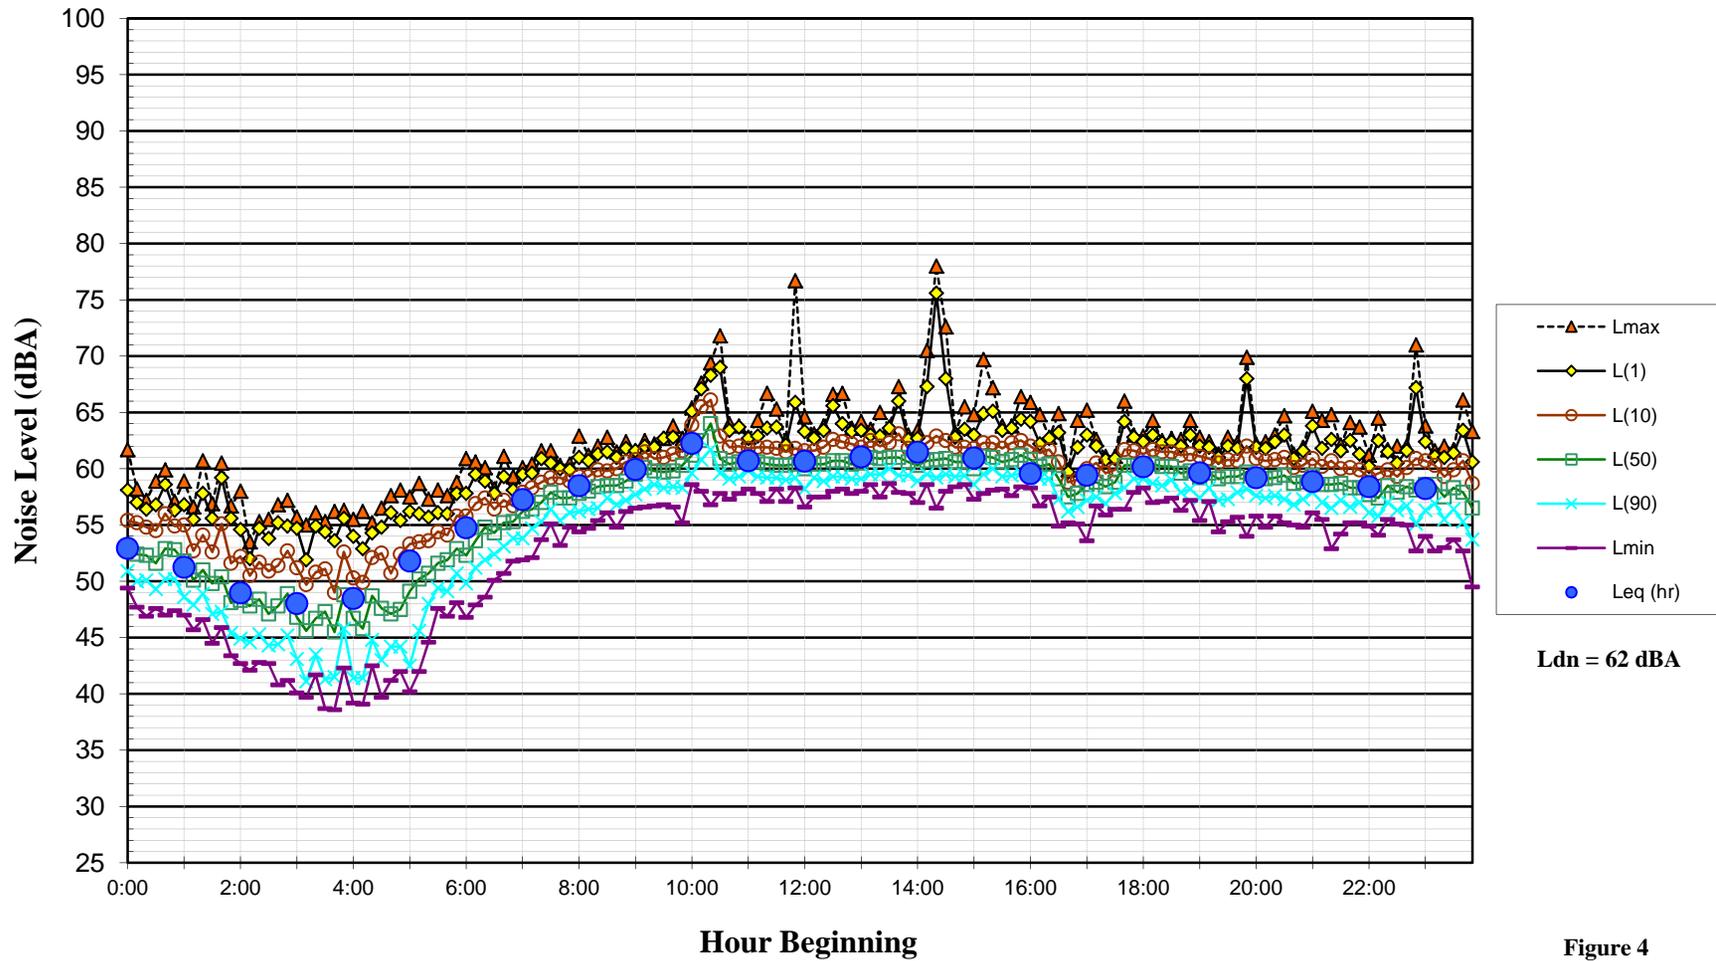
Figure 3

**Noise Levels at Noise Measurement Site LT-1
Northwest Portion of Site, ~800 feet from the Center of SR-17
Saturday, December 8, 2012**

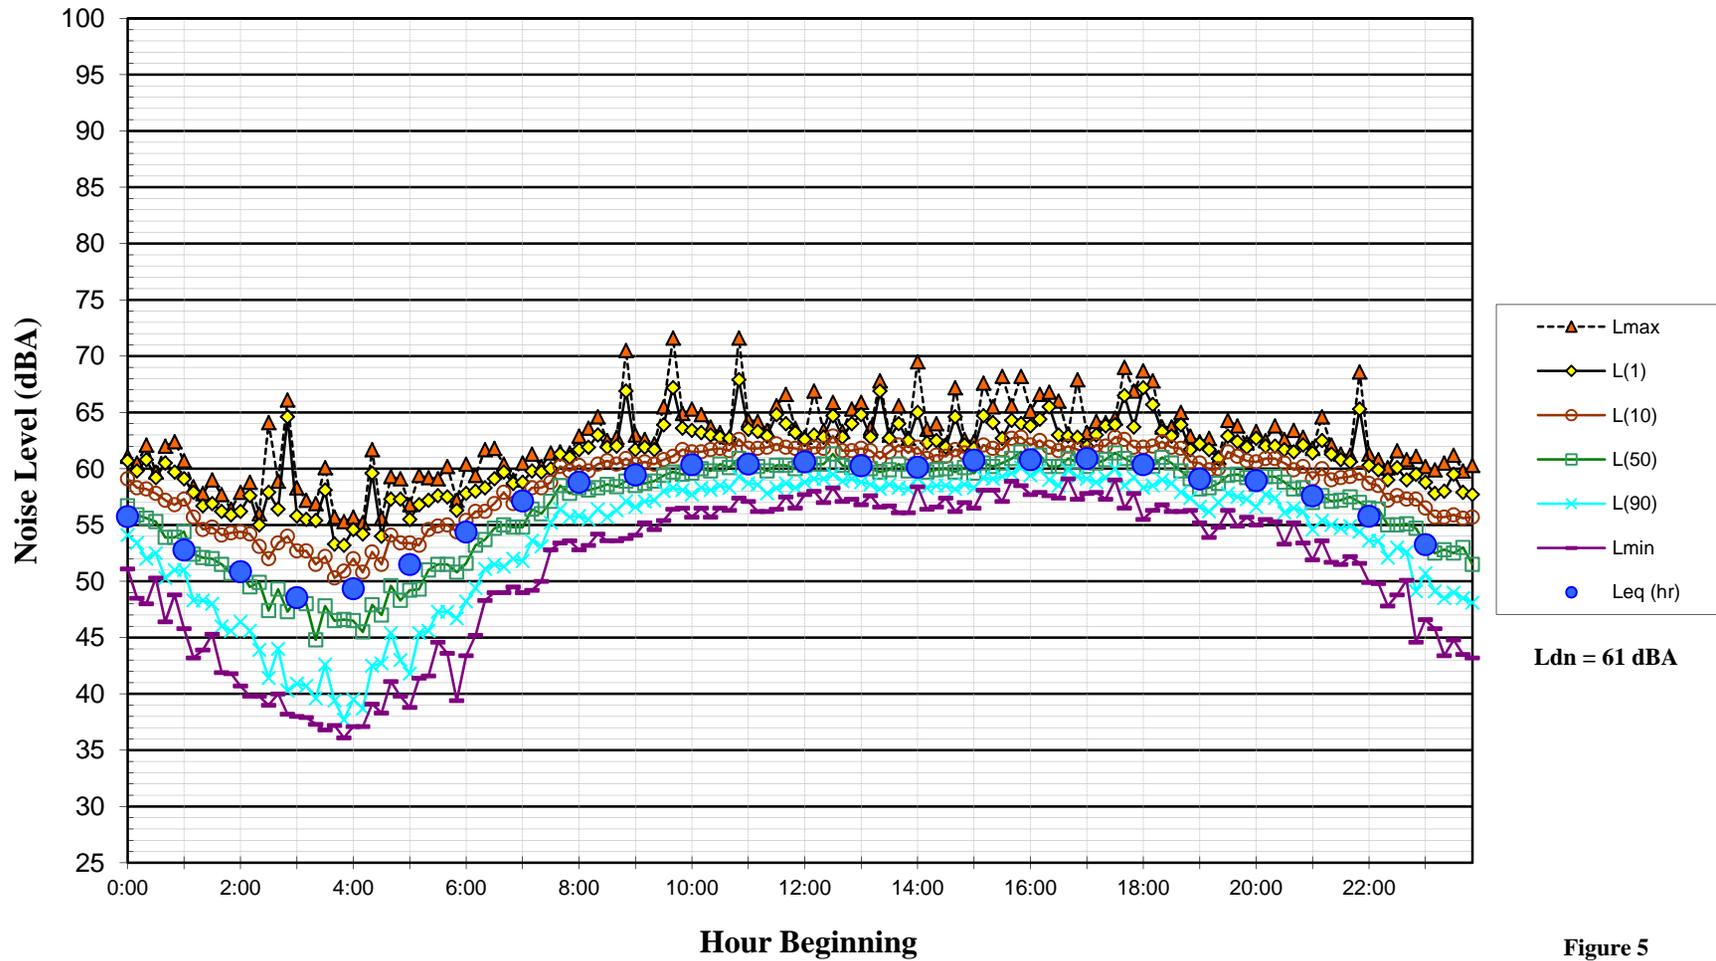
Figure 4

**Noise Levels at Noise Measurement Site LT-1
Northwest Portion of Site, ~800 feet from the Center of SR-17
Sunday, December 9, 2012**

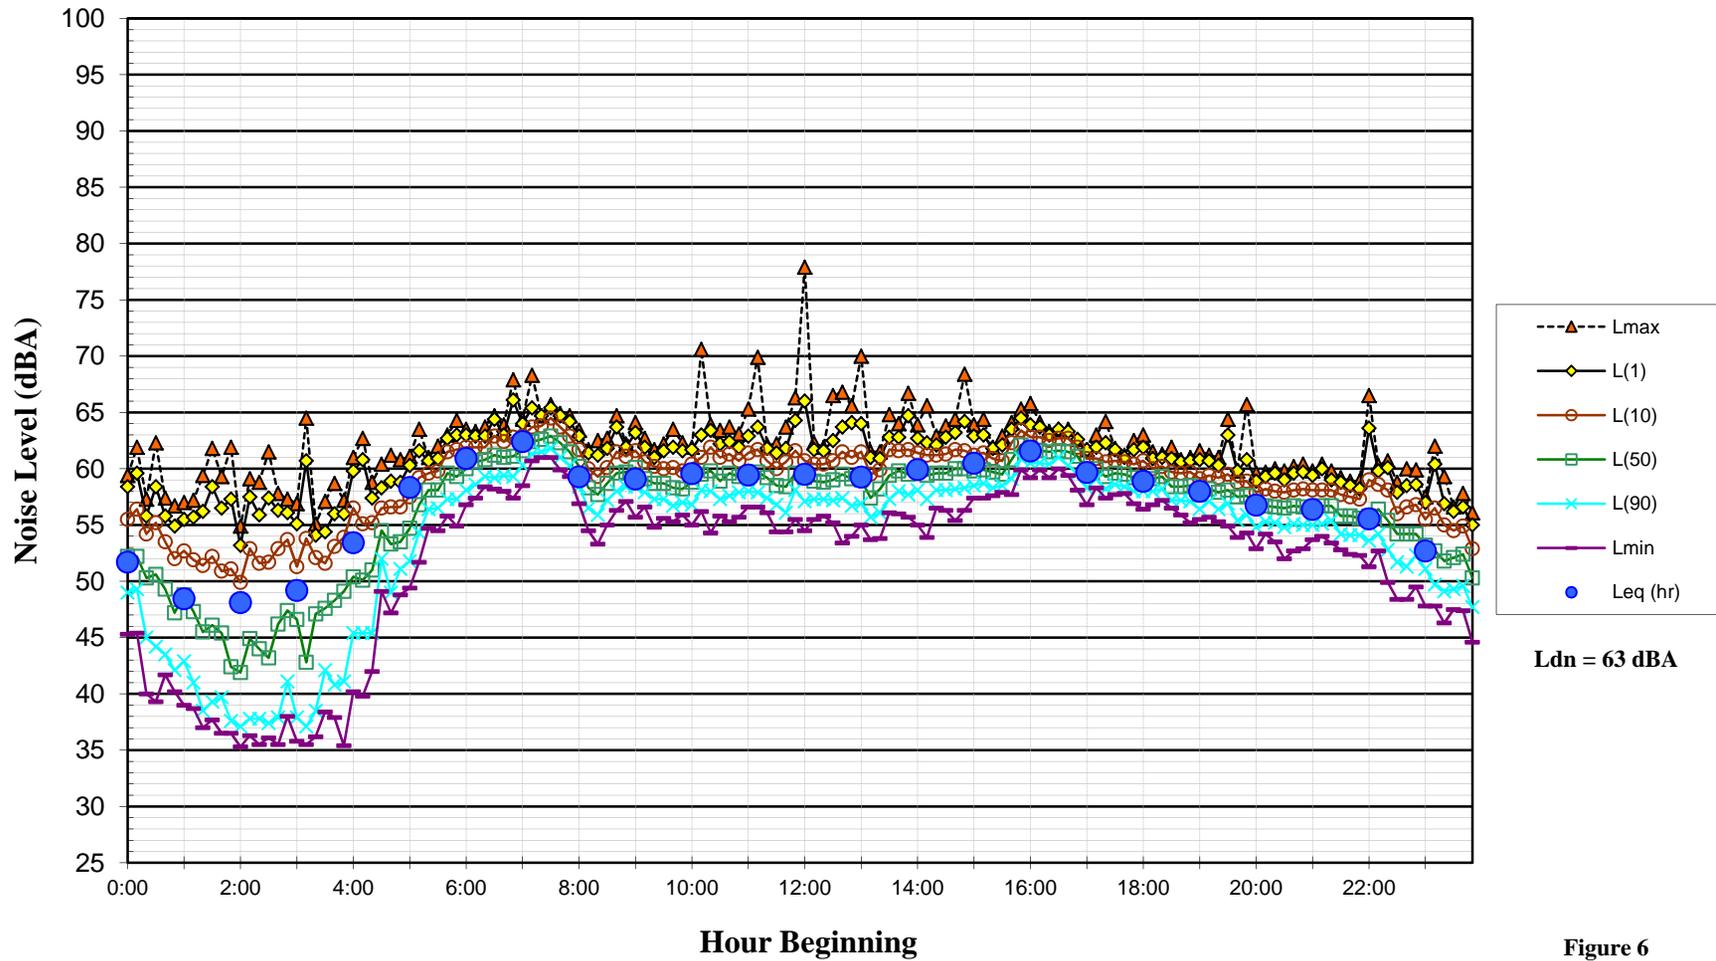
Figure 5

**Noise Levels at Noise Measurement Site LT-1
Northwest Portion of Site, ~800 feet from the Center of SR-17
Monday, December 10, 2012**

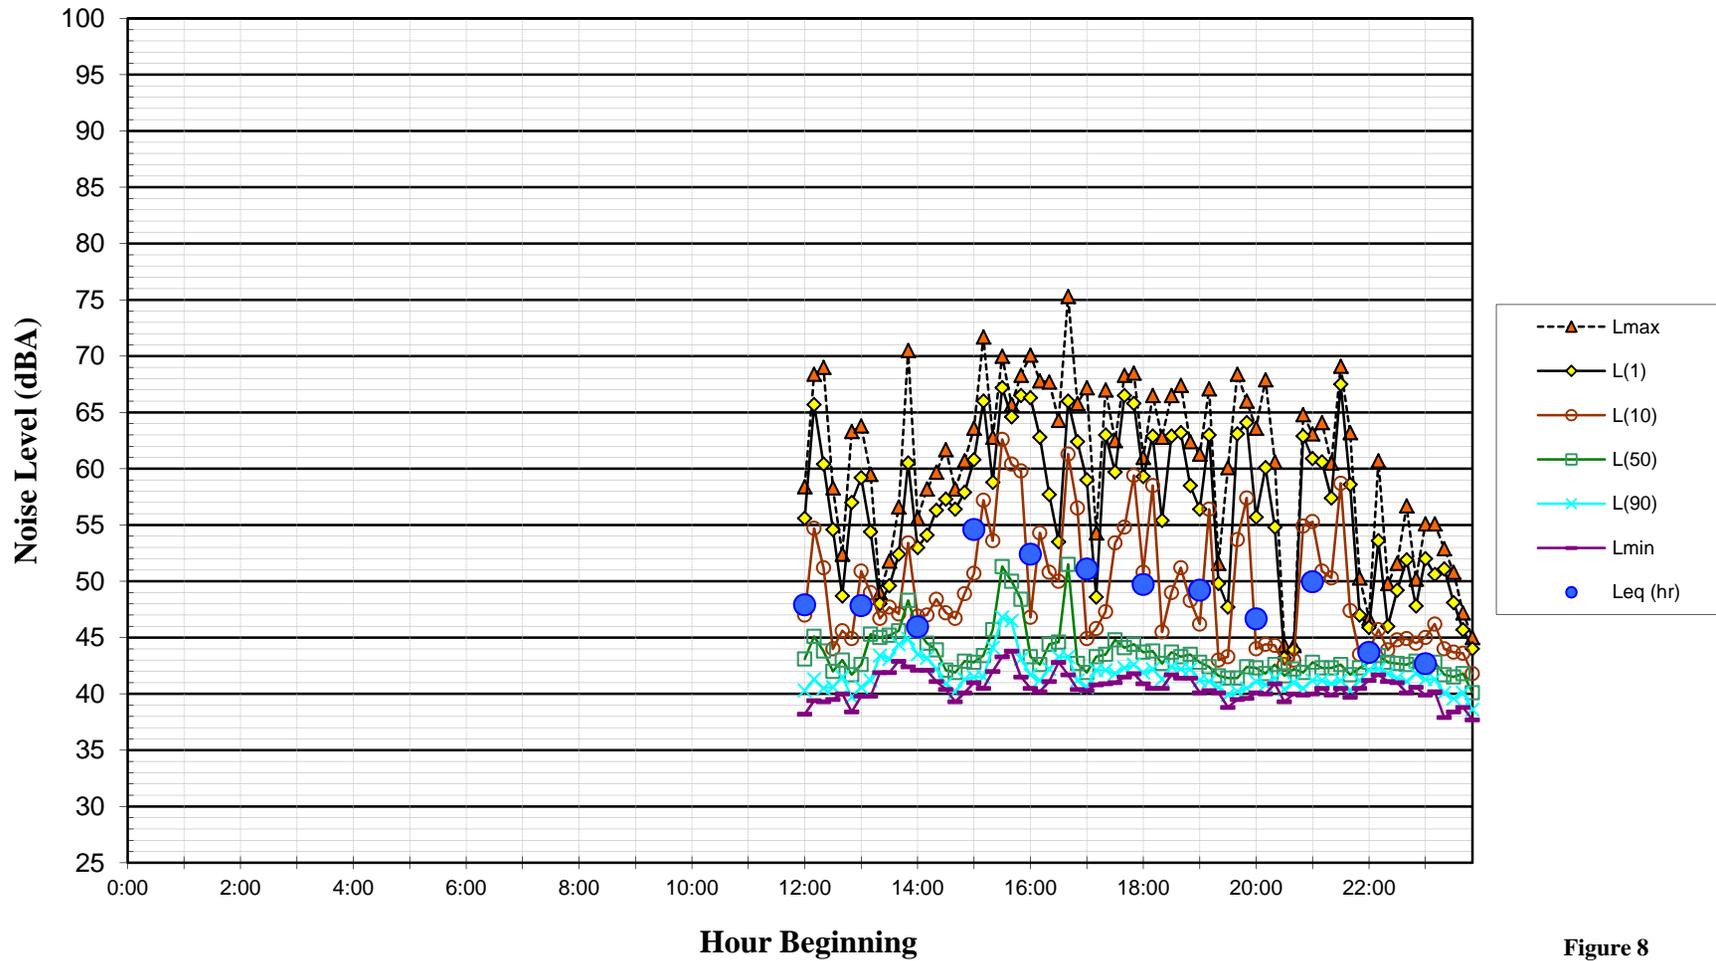
**Noise Levels at Noise Measurement Site LT-2
Adjacent to Prospect Avenue
Thursday, December 6, 2012**

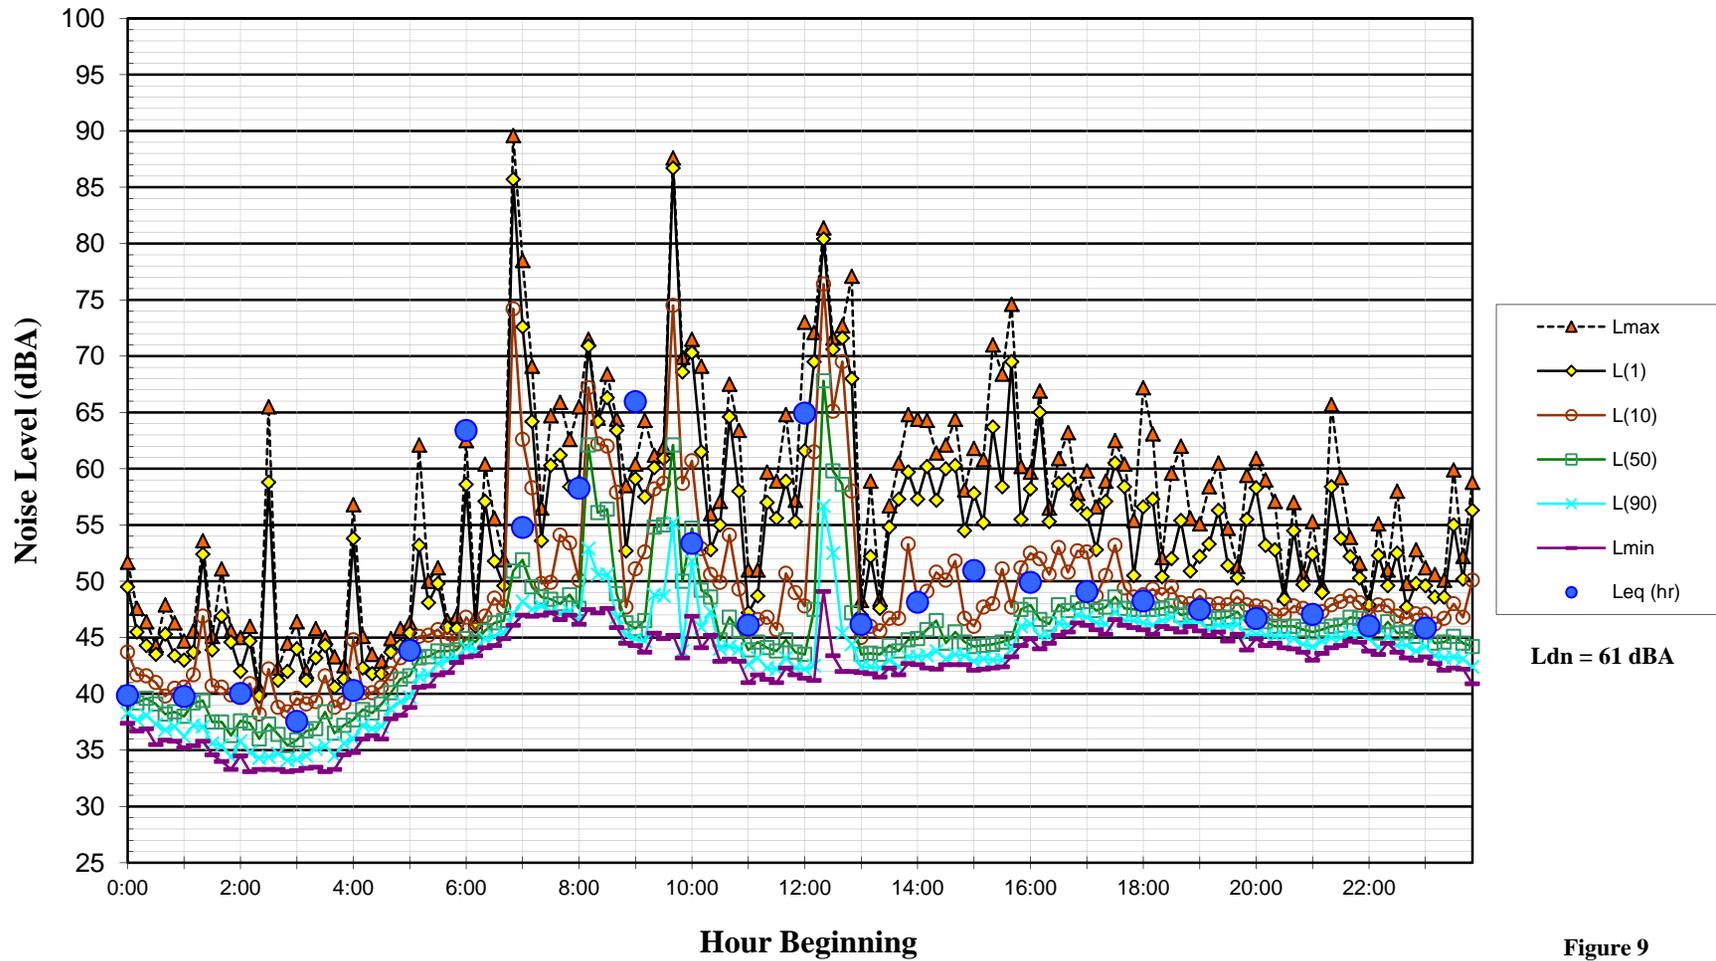
Figure 8

**Noise Levels at Noise Measurement Site LT-2
Adjacent to Prospect Avenue
Friday, December 7, 2012**

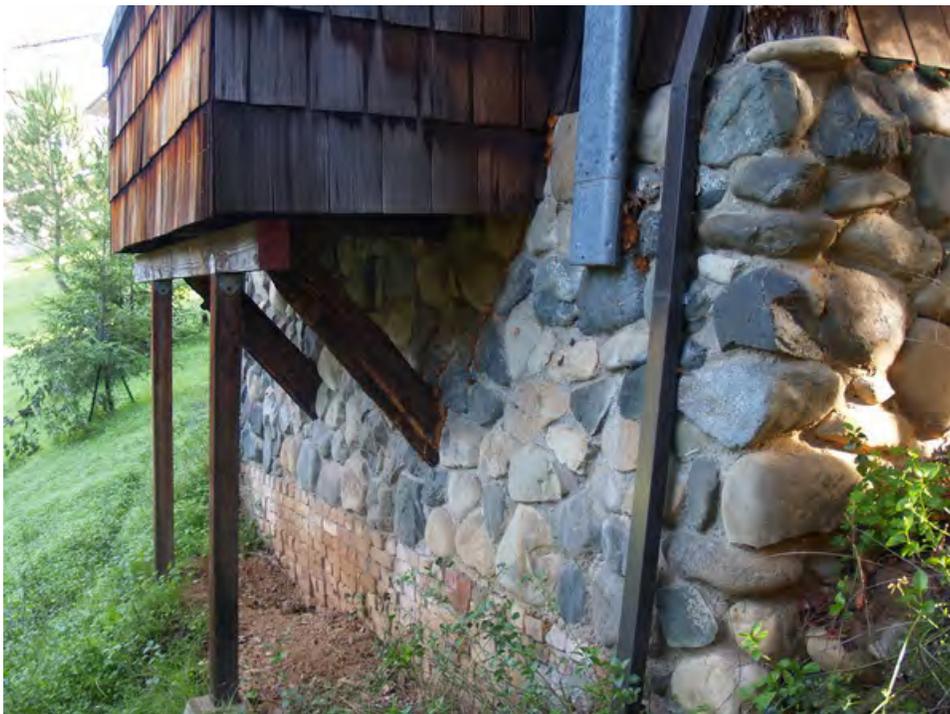
Detail view of rear of Stone House foundation stone.

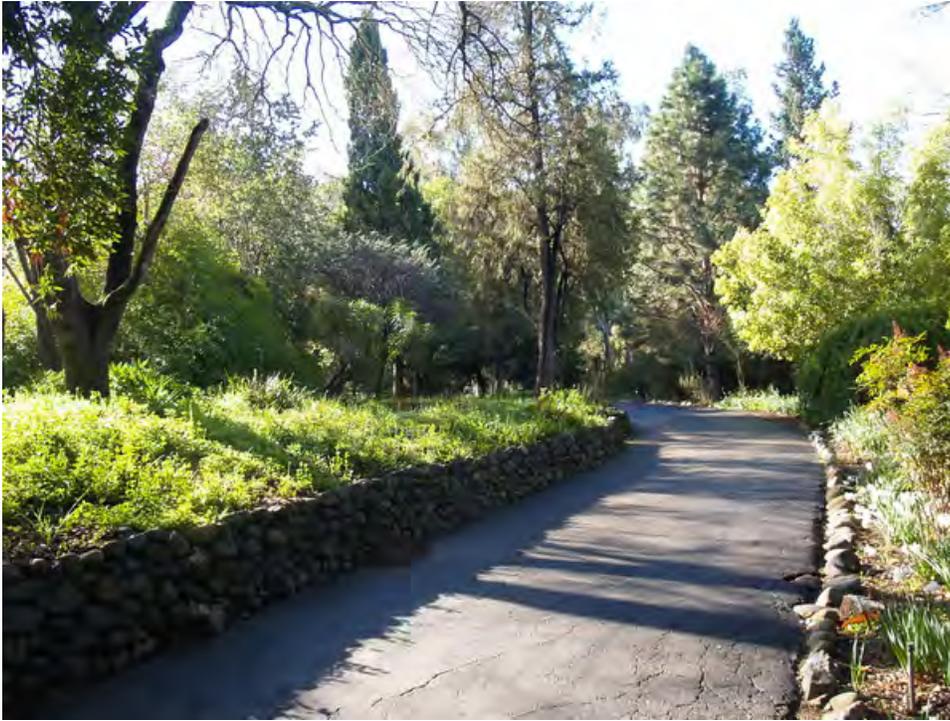
Walls at internal road above Stone House.

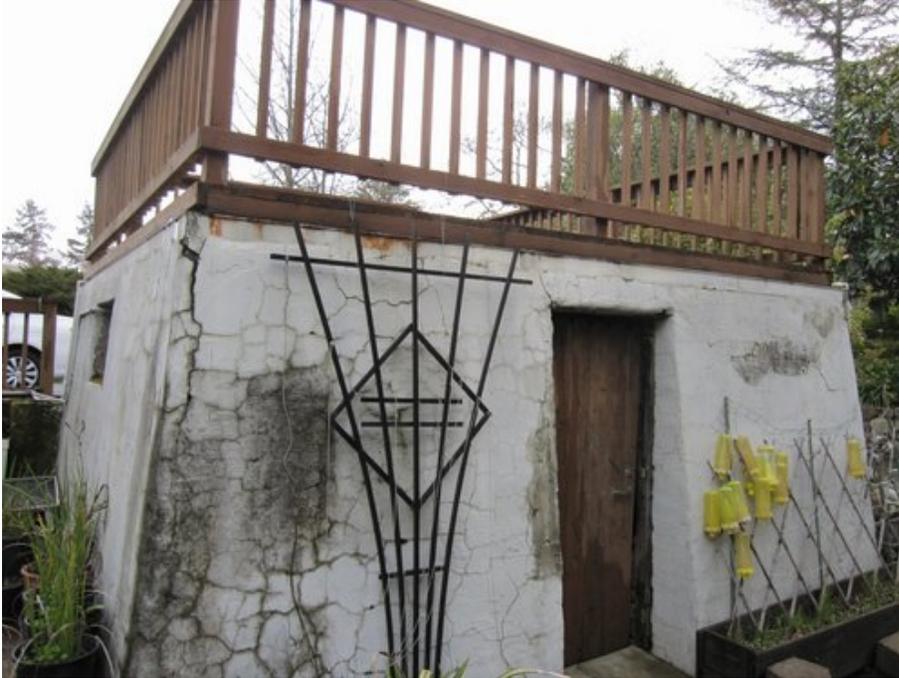
Photograph 5. Former water tank foundation.
